Practical Experience Gained from Dissolved Gas Analysis at an Aluminium Smelter

As Presented at EuroTechon 2011

This paper will provide a summary of Hillside Smelter Transformer faults detected by Dissolved Gas analysis at Early Life

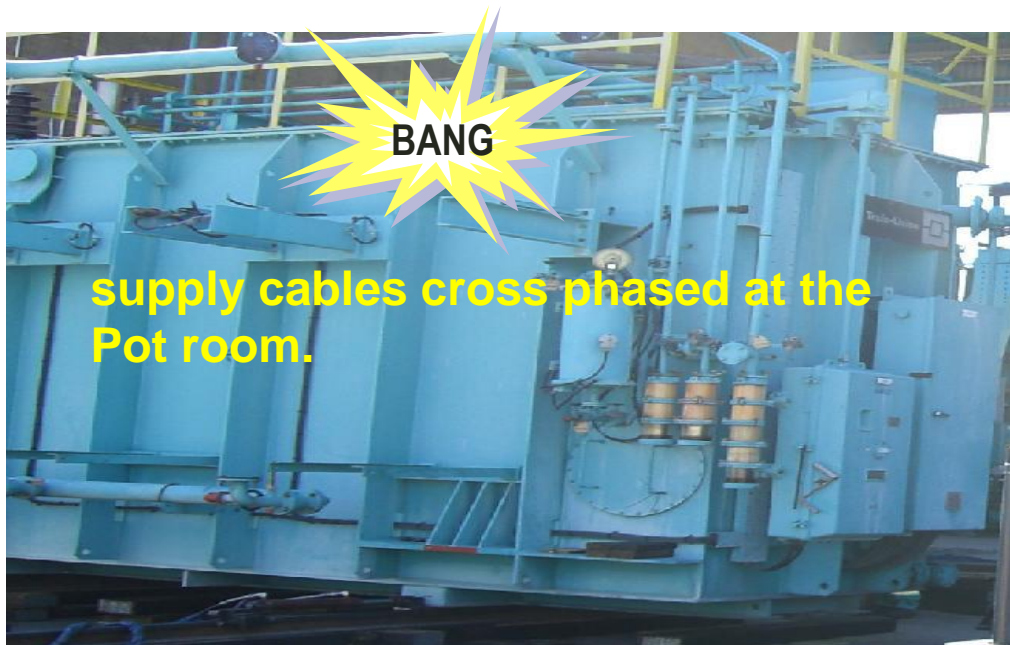
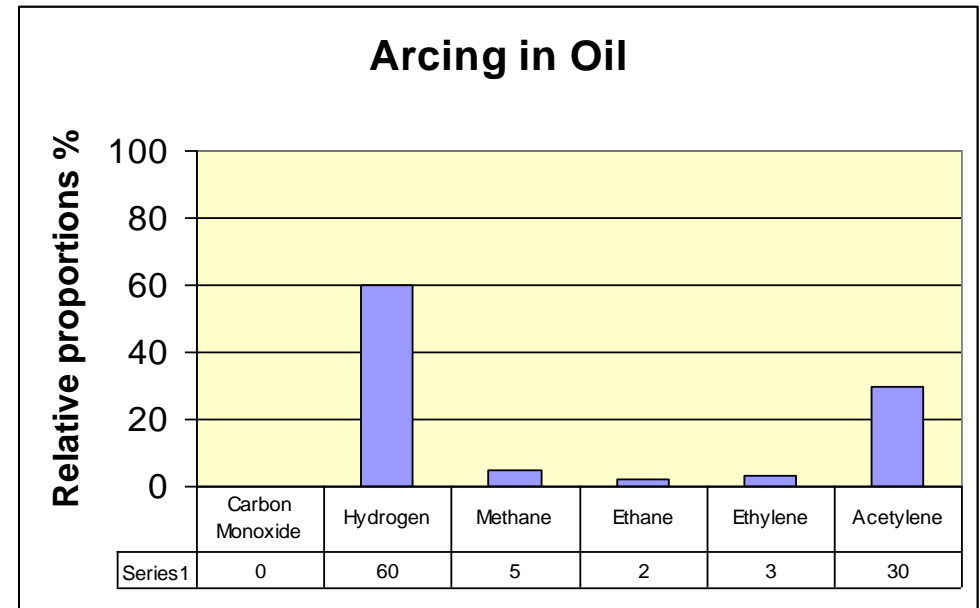
Failure Event Regulator Transformers

It was found that there was major damage to the internal 22kV reactor in both cases.

The root cause was found to be a weakness in the Regulator transformer design.

The manufacturer had to change the design to an External 22kV Reactor for each Regulator transformer

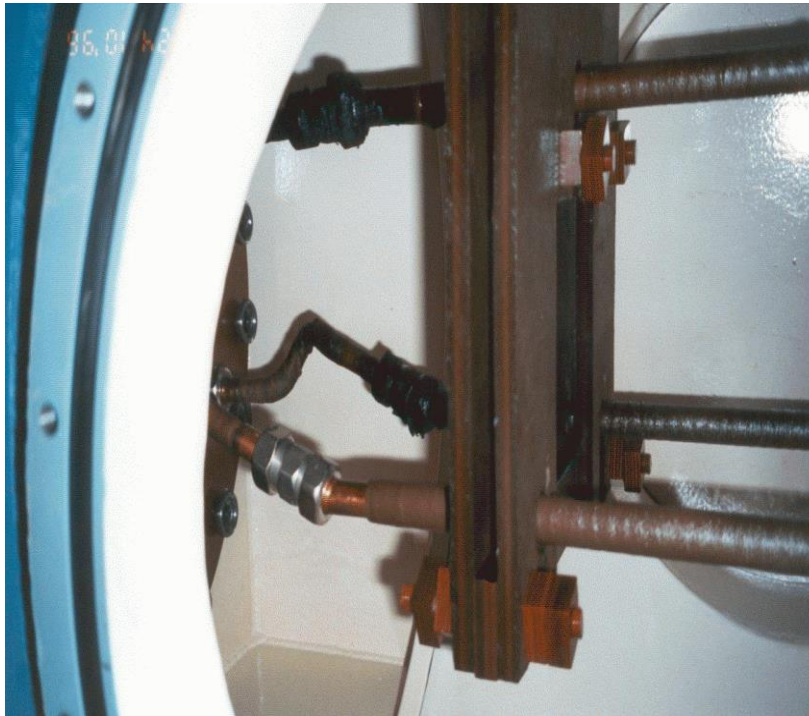
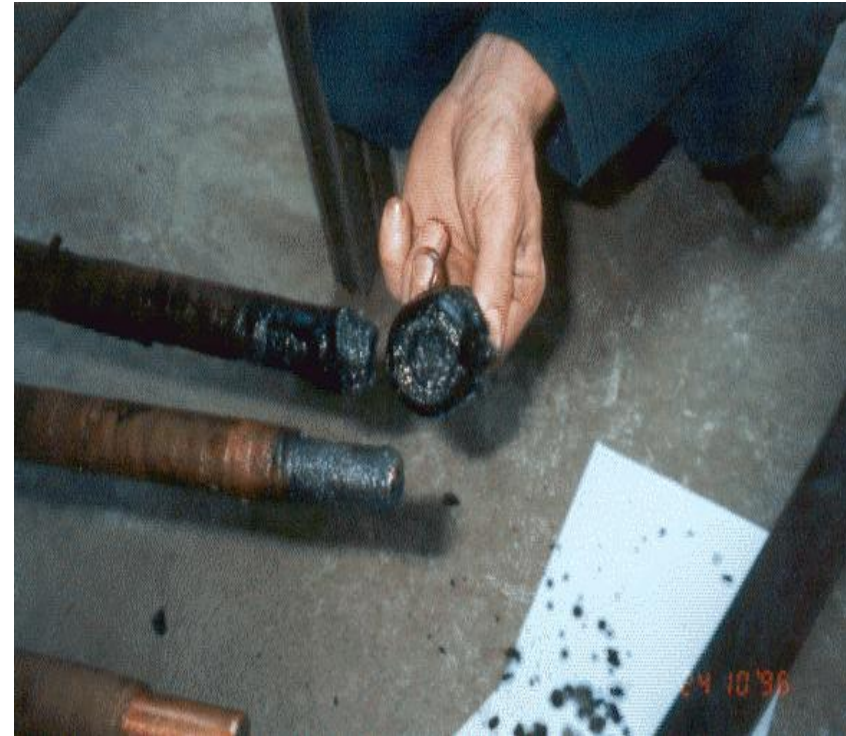
The internal inspection of the Main Chamber found burnt (overheated) connections

The root cause was found to be being non-conforming quality control during installation

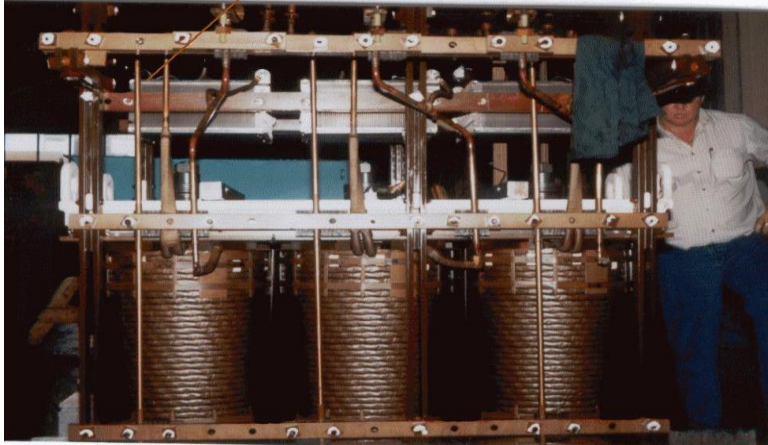
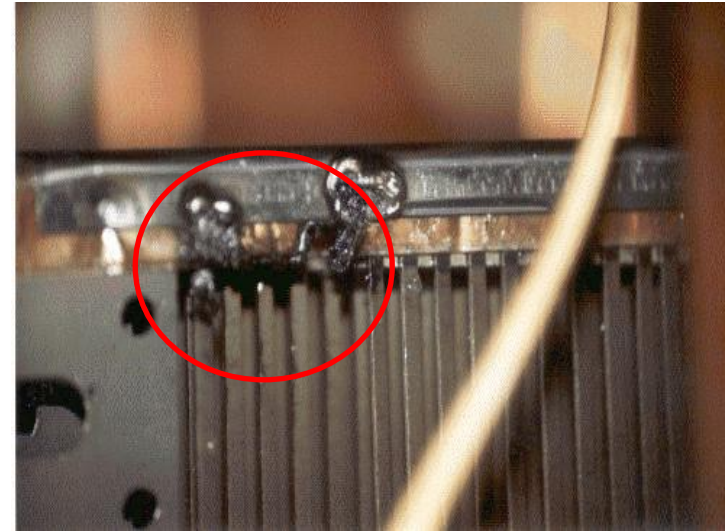
Burning occurring on resistor bank

not established

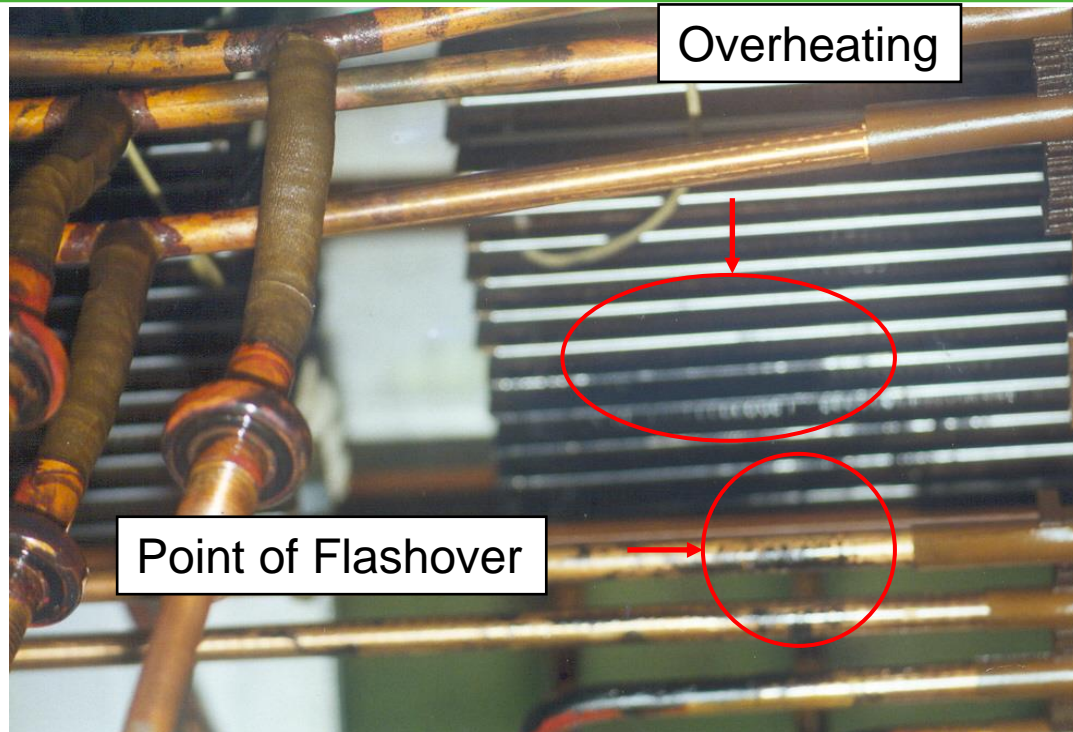
BAY 13 Reactor Transformer

Fifth Harmonic being amplified within the transformer causing it be subjected to 10 times its rated current for a couple of milli-seconds. Design fault involving the power factor correction. (Weakness in design).

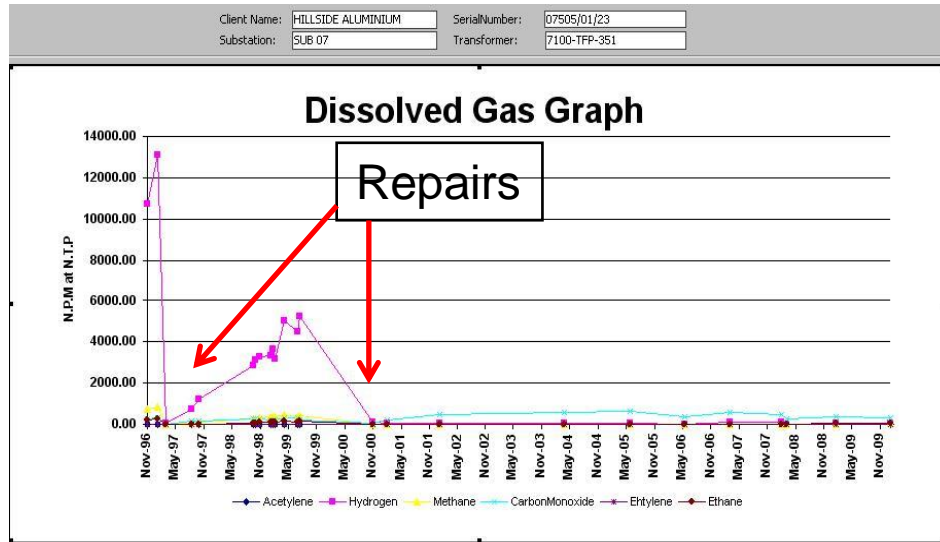
Loose internal earth strip

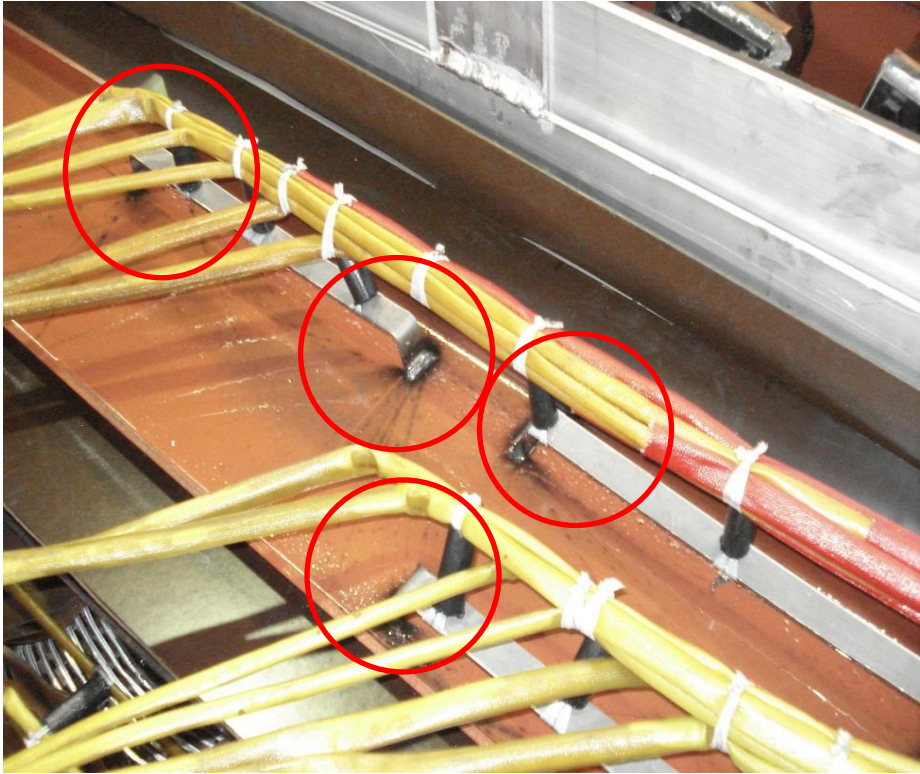
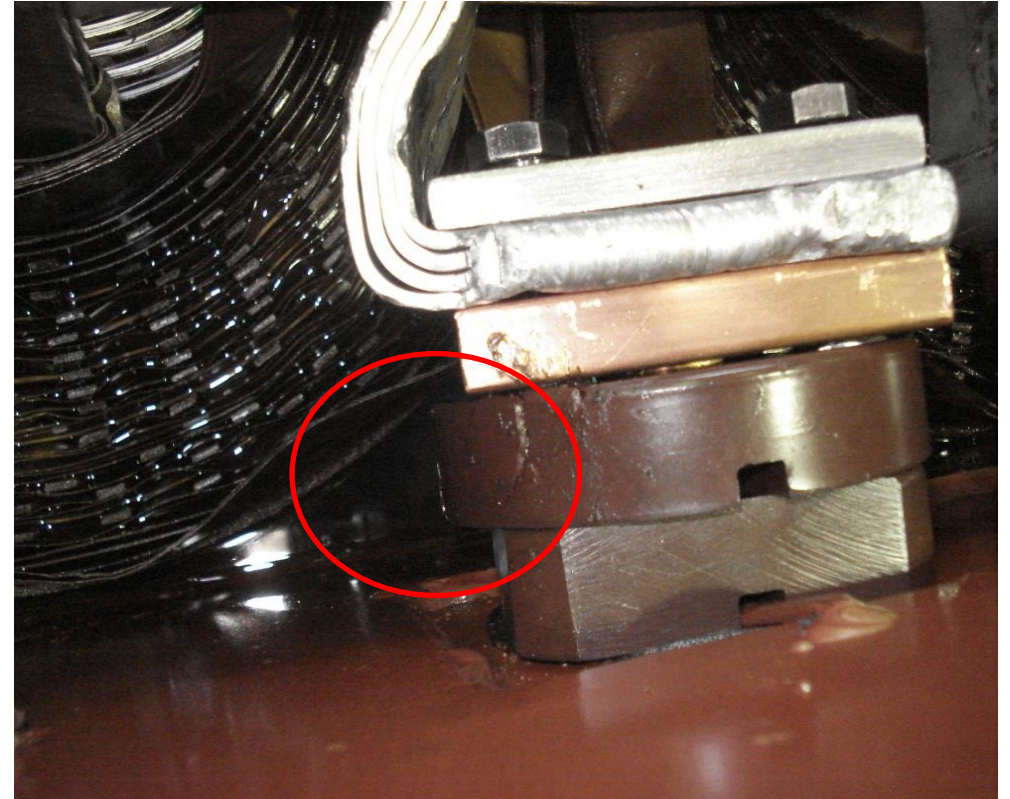
The root cause was established to be weakness of design and non-conforming quality control during manufacture.

Savings: The transformers were repaired under warranty.

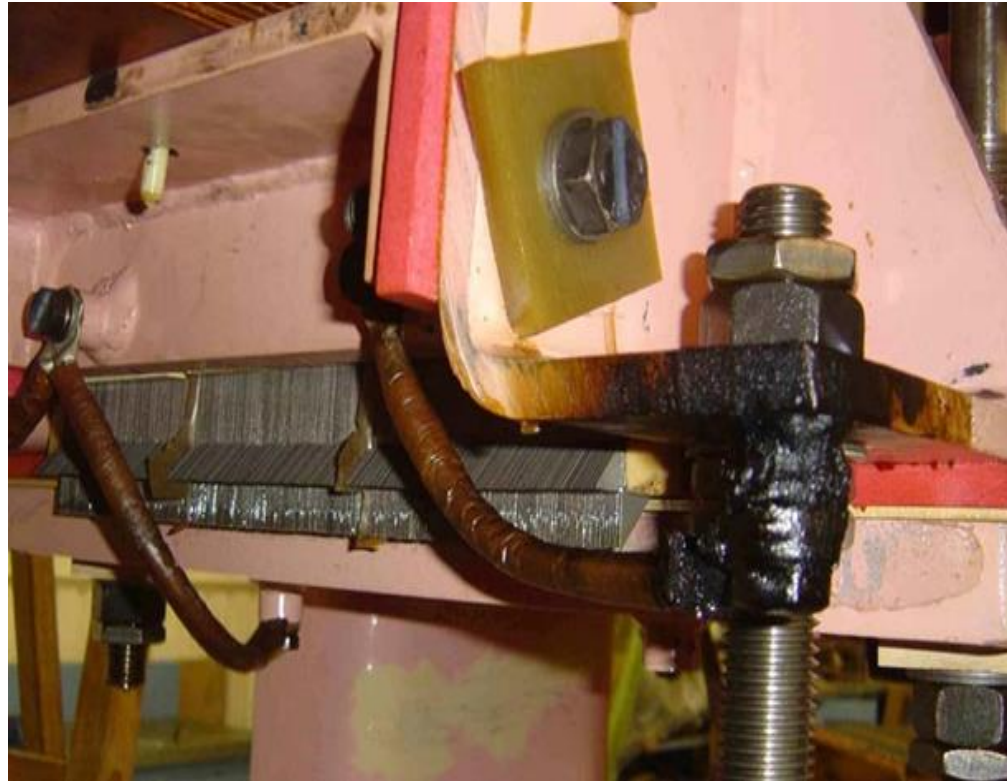
Termination for potential connection became a hot spot due to circulating current

The transformer was repaired at a works facility under the warranty of the OEM.

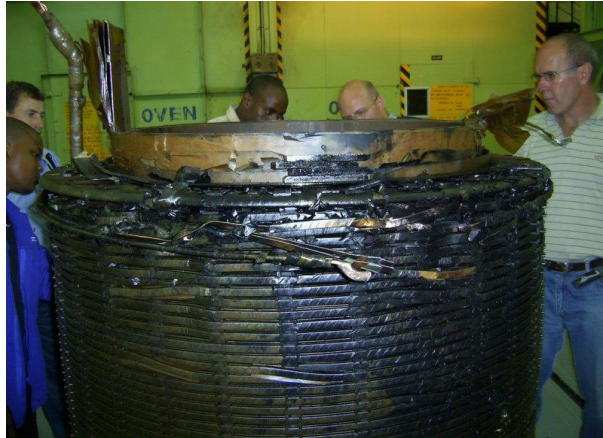
High Voltage winding open circuit and flashed to core

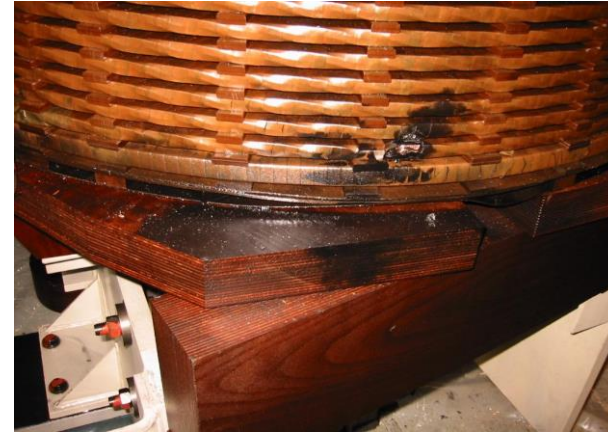
Burning in the vicinity of the top core earth strap

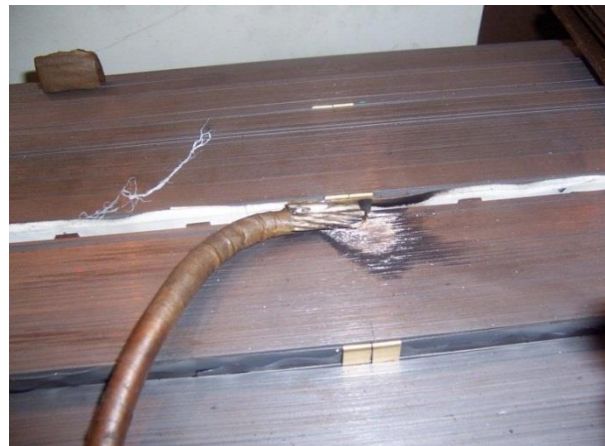
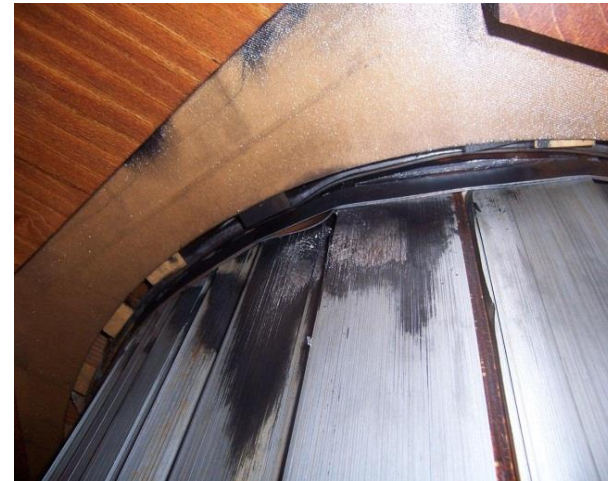
Overheating of the Core

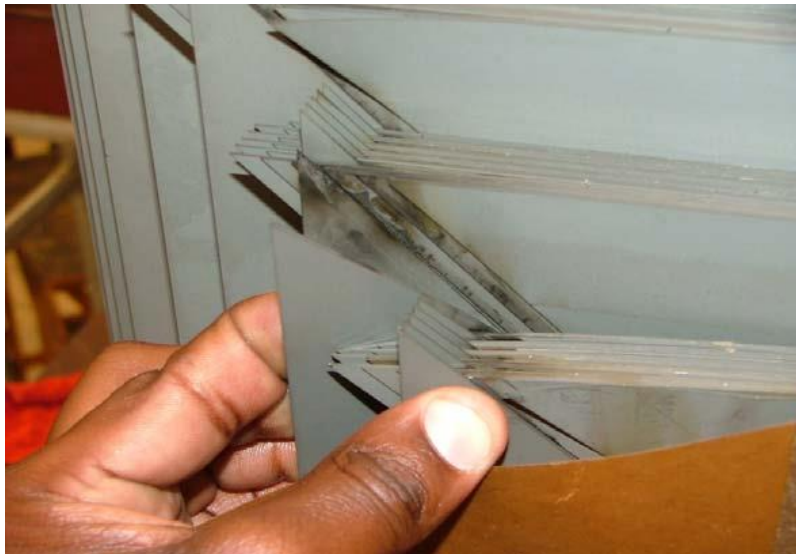
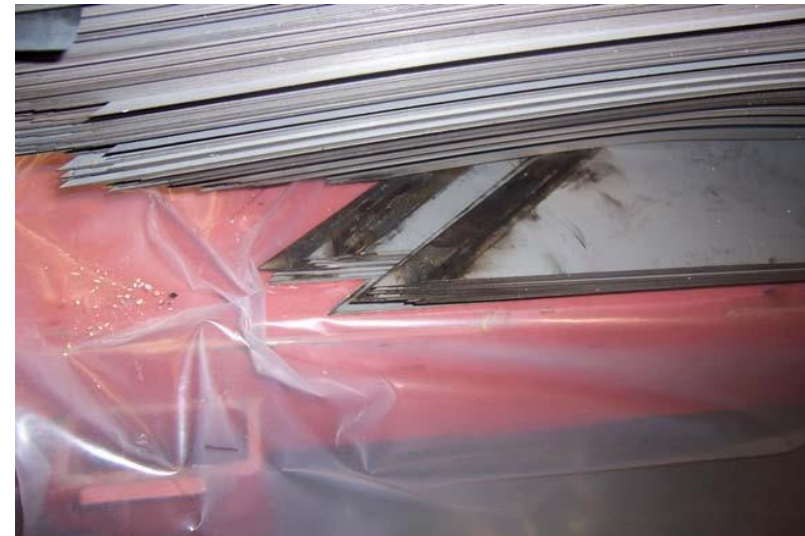
Striking resemblance of core defect between T22 and T21

- Root cause of gassing was attributed to a poor shielding design or reduced cross sectional area of core
- Early retirement of all Rectifiers of this design.
- On Line DGA monitors installed
