Practical Experience Gained from Dissolved Gas Analysis at an Aluminium Smelter

By Ian Gray(MSA Chem I No 51954 as Presented at EuroTechcon 2011

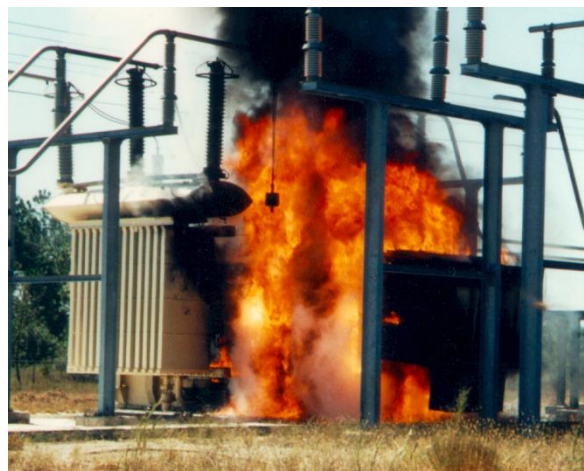
Figure 4
Catastrophic transformer failure

In the event of failure, the force applied to the structure may approximate 360 PSI due to the steep wave front and high velocity, representing a loading sufficient to distort the container or shear the holding bolts and possibly cause a transformer oil fire. See Figure 4 showing catastrophic transformer failure

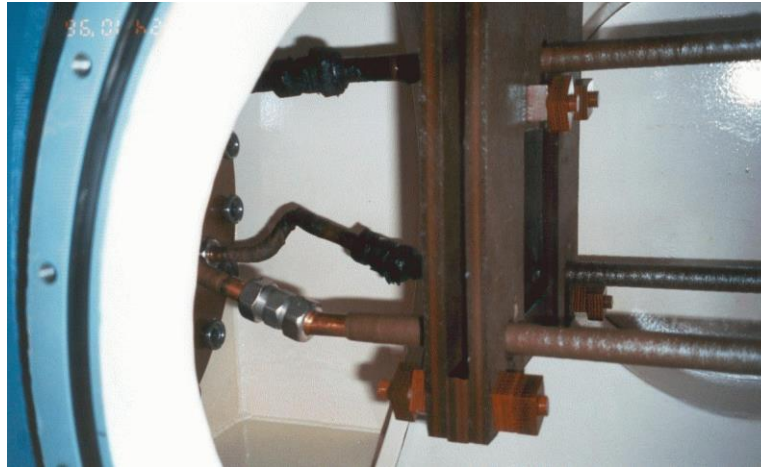
Figure 15(A)
Burnt (overheated) connections

The internal inspection of the Main Chamber found burnt (overheated) connections. See Figures 15A-B the connections overheated because they had not been tightened to the Manufacturers specification.

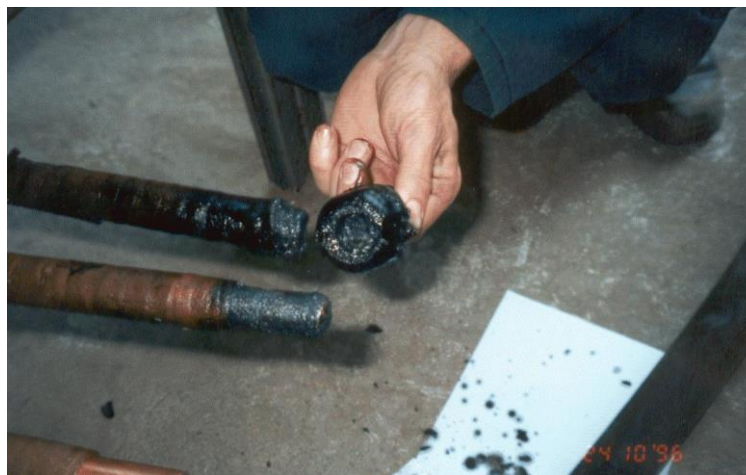
Figure 15(B)
Burnt (overheated) connections

The root cause was found to be being non-conforming quality control during installation
Savings in the R Million range: By accurately diagnosing the fault type and location the manufacturer saved significant time and equipment to effect repairs.
The smelter saved minimum down time on production

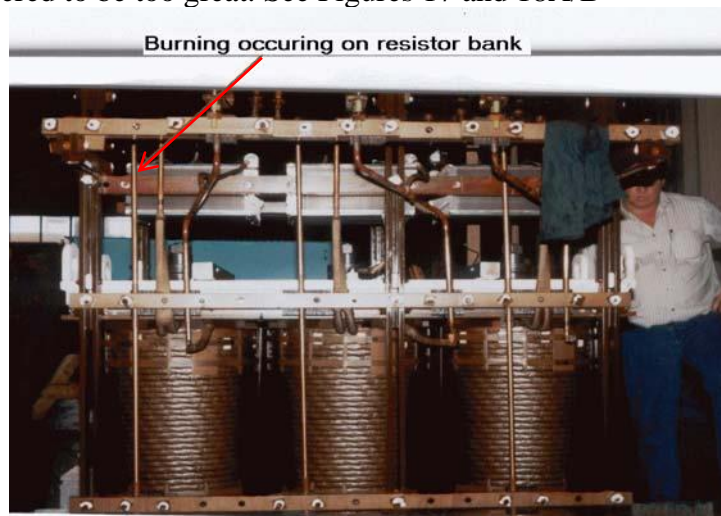
The fault classification had not changed from 06/02/1998 with the IEC 599 Ratio's giving a Thermal fault of High temperature range $>700^{\circ}\text{C}$. The other Ratio methods gave a similar fault condition.

Figure 17
Showing the point on the Resistor bank where the Overheating was occurring

It was recommended to remove this unit from service immediately as the risk of catastrophic failure was considered to be too great. See Figures 17 and 18A/B

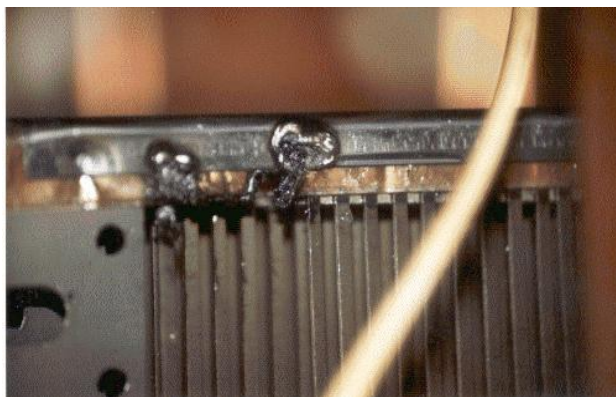
(A)

A-showing the actual point of burning on the resistor bank point and 18 B-showing a metal strip that had burnt off the resistor bank.

The unit was returned to service after repairs but the root cause had not been established. The initial theory was that the cross sectional area of the metal strips was insufficient for the magnitude of the current.

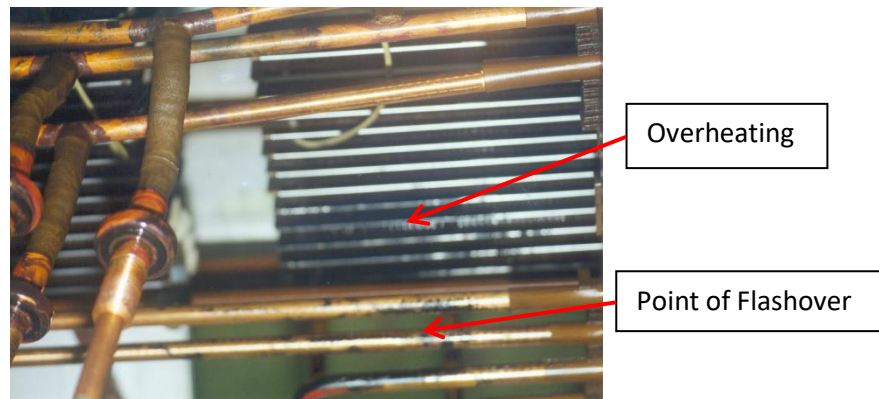
Figure 21

The internal inspection found overheating and burning on the resistor bank and a flash-over had occurred on the bare copper conductor above the resistor bank. See Figure 21.

Showing the overheating on the resistor bank and the point of flash-over

The overheating on the resistor bank as a result of voltage stress caused gas bubble formation. Gas bubbles have a lower dielectric strength than either oil or the oil-impregnated solid insulation under normal conditions. Bubbles therefore can be a source of partial discharge activity or in this case a discharge of high energy.

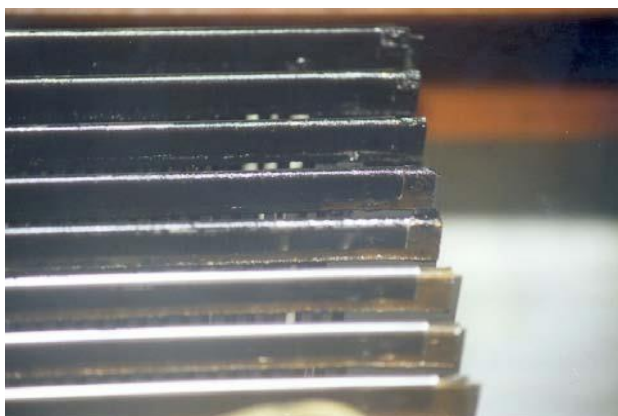
(A)

Figure 22 A-shows the actual point of overheating on the resistor bank point and 22 B-shows the point of flash-over with the carbonisation on the copper conductor.

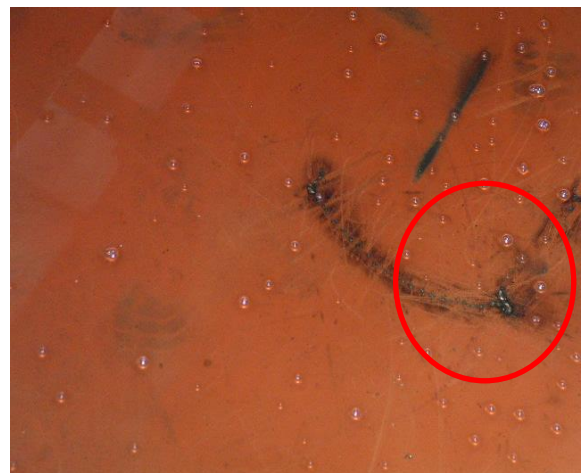
(B)

Sediments were detected to be deposited over the top frame channel as well as on the bottom of the tank. Carbon marks were detected over the bottom core-clamp insulation-See Figure 25B.

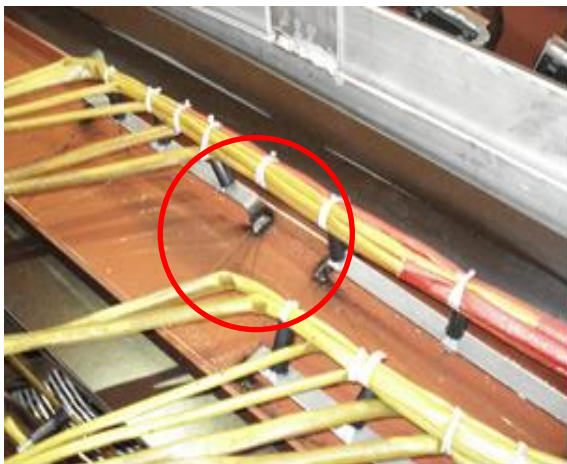
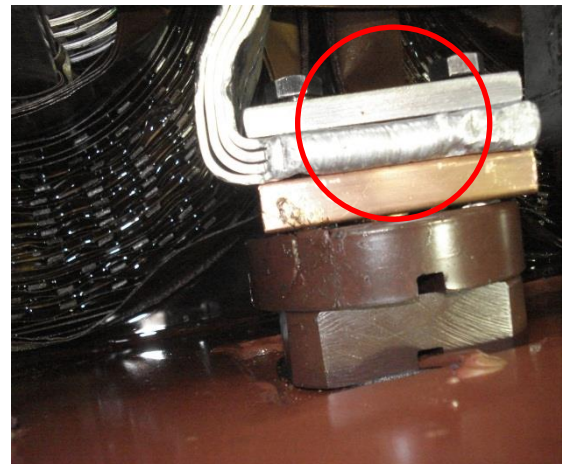
- LV busbar welded connections from winding to bushing showed cracks on at least three areas
- Bushing crack observed on LV c phase
- Bushing damage observed on LV a phase

See Figures 28 A and B
Showing the Partial Discharge activity

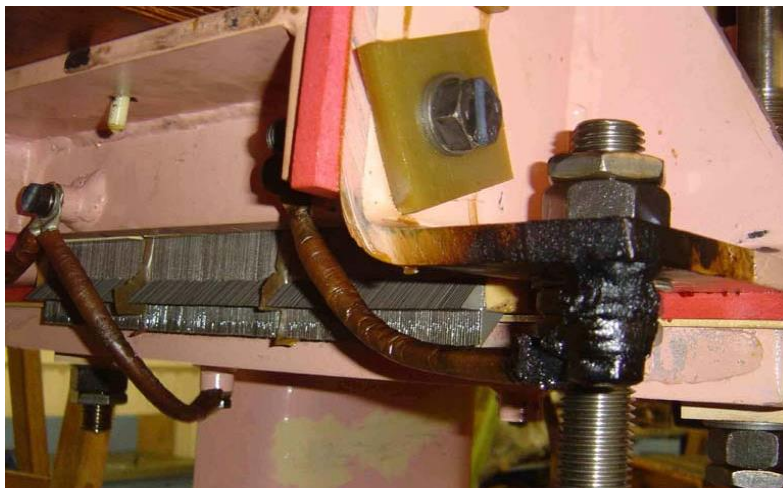
Figure 31: Termination for potential connection became a hot spot due to circulating current

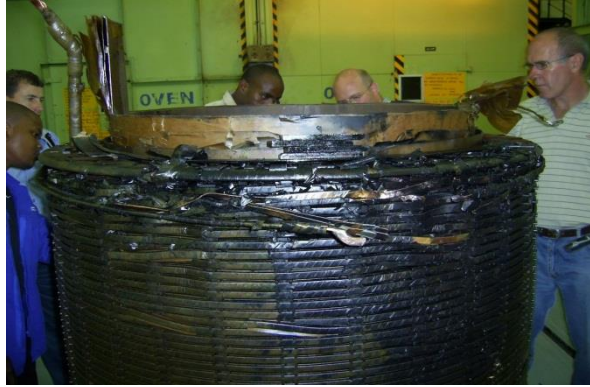
The flash mark on the A-phase LV winding was on the outer surface of the disc at the bottom of the winding. The blocks underneath the winding showed movement as a result of the flash over between the A- phase HV winding and core.

Figure 36
Shows the damage on the HV winding

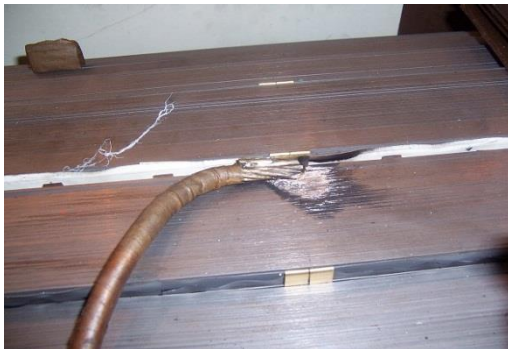
(A)

Burning in the vicinity of the top core earth strap between A and B phases as a result of the fault currents during the HV flash over. See Figure 37A.

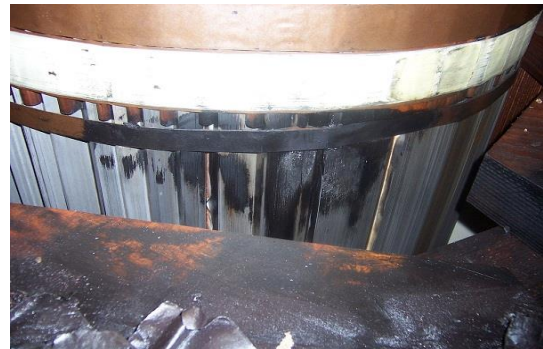
(B)

Overheating of the Core. See Figure 37 B.

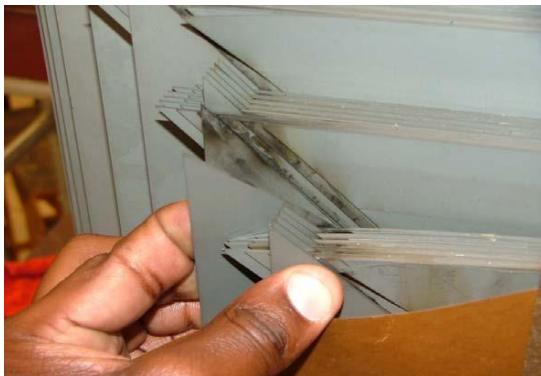
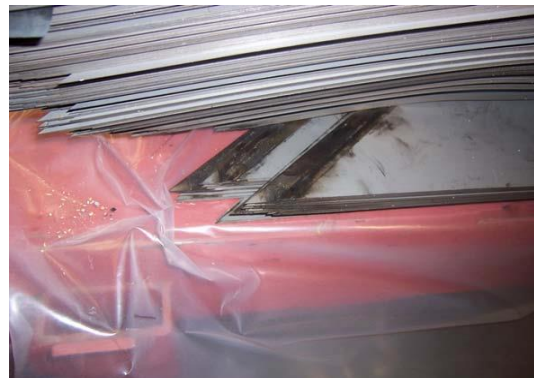
Root cause of gassing was attributed to a poor shielding design or reduced cross sectional area of core

Figures 38 A and B
Show the Core overheating. A is T21 and B is T 22
