Transformer failures are costly

by Ian Gray, Oilwatch Transformer Services

Case example: rectifier transformer

Condition monitoring and failure event: Bay 22 rectifier

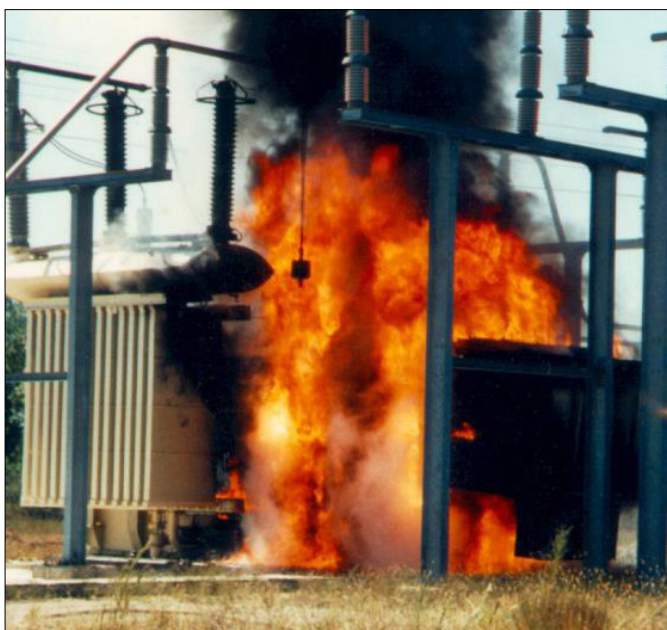
Figure 3: Catastrophic transformer failure

In the event of failure, the force applied to the structure may approximate 360 PSI due to the steep wave front and high velocity, representing a loading sufficient to distort the container or shear the holding bolts and possibly cause a transformer oil fire.

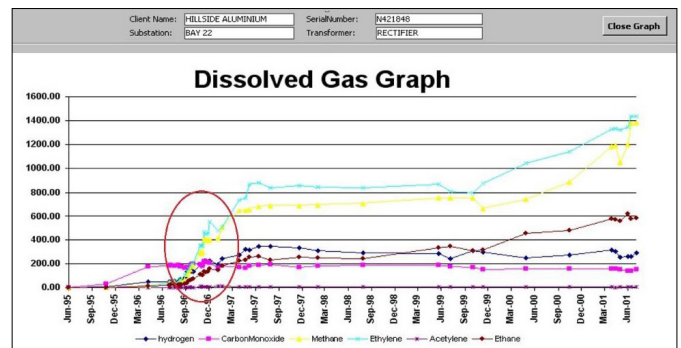
Figure 4: DGA trend up to July 2001

The DGA on this transformer showed abnormal gas production of hydrogen, methane, ethylene and ethane about 20 months after energising. The fault condition was diagnosed as a thermal fault of medium temperature in the range 300°C and 700°C. The recommendation at 30/09/1996 was to remove the unit from service for inspection.

The exponential rise can be seen from 1996 to 1997.

The frequency of oil sampling was increased as the transformer was under warranty and the manufacturer ultimately had the decision on whether to remove a transformer from service for inspection. It is interesting to note the gas production after July 1997 showed only a slight rate of rise.

However, after the oil de-gassing in July 2001, the same phenomenon of exponential gas production followed by a levelling off was seen (See Figure 3). This can be explained in part by the IEC 60599 code that reports that there can be gas diffusion losses for in service equipment. However, there is no agreement concerning the magnitude.

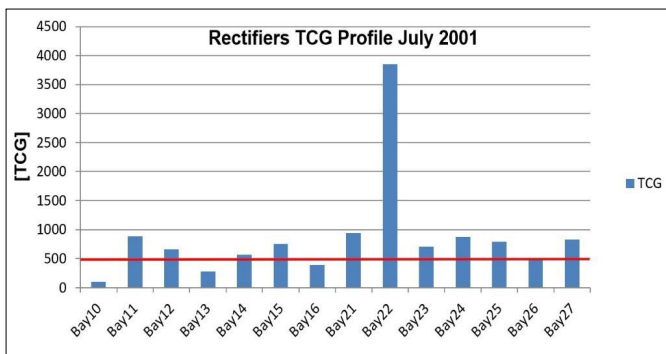
Figure 6: Total combustible gas profile at July 2001

This transformer was ranked as having the highest risk of failure, based on the DGA-Total Combustible Gas Profile (See Figure 6). The condition was monitored by regular oil samples. On-line DGA was considered.

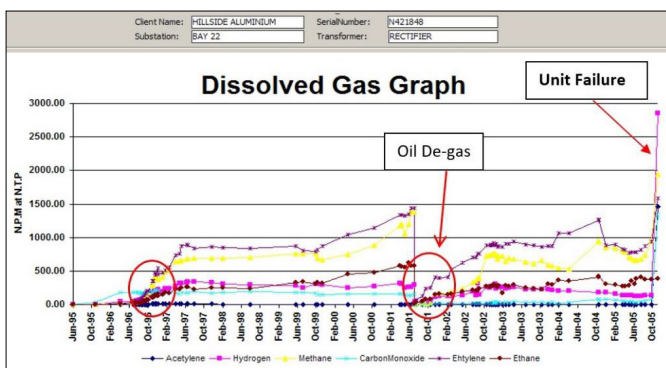
Figure 7: DGA trend

At 16:32, on the 18 November 2005, Transformer T22 failed catastrophically. An urgent DGA sample confirmed that a discharge of high energy (arcing) had occurred (See Figure 7).

‘A’ phase high voltage winding open circuit and flashed to core (See Figure 7).

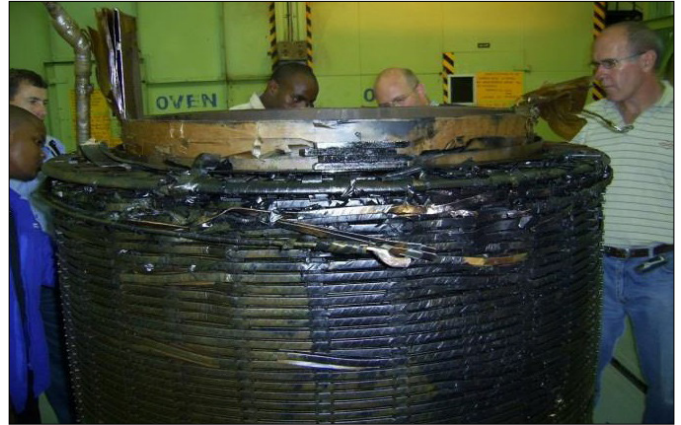
Figure 8: Damage to the HV winding

Fault type. Red phase, HV-LV-core-tank-earth fault

The flash mark on the A-phase LV winding was on the outer surface of the disc at the bottom of the winding. The blocks underneath the winding showed movement as a result of the flash over between the A-phase HV winding and core.

The production of gas in the HV winding seems to have leaked past the LV winding, affecting the dielectric strength of the oil between the LV winding and the tank. This resulted in a secondary flash-over from the LV winding to the tank.

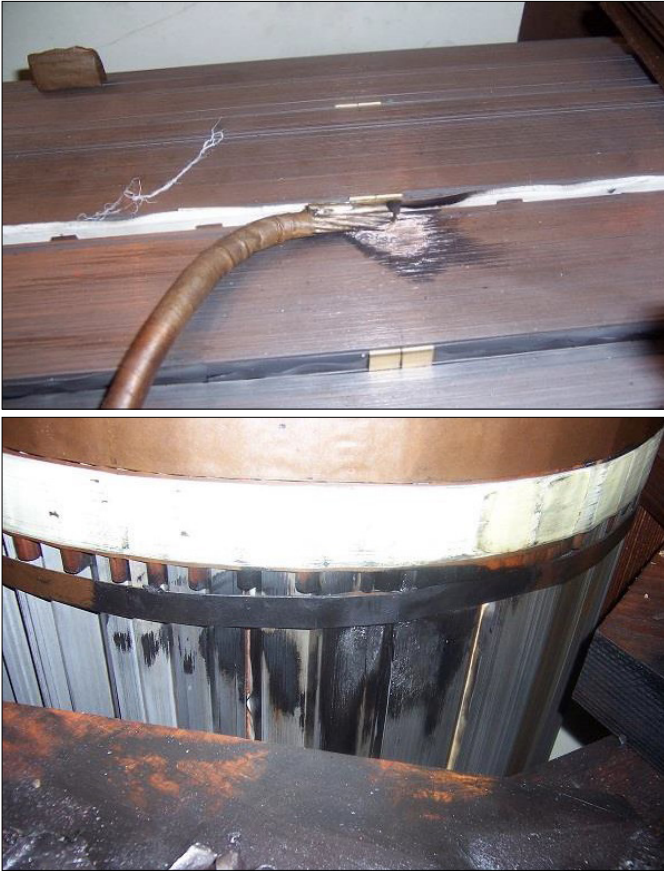
Figure 9: The sites of overheating

Burning in the vicinity of the top core earth strap between A and B phases as a result of the fault currents during the HV flash over.

Overheating of the core. See Figure 9.

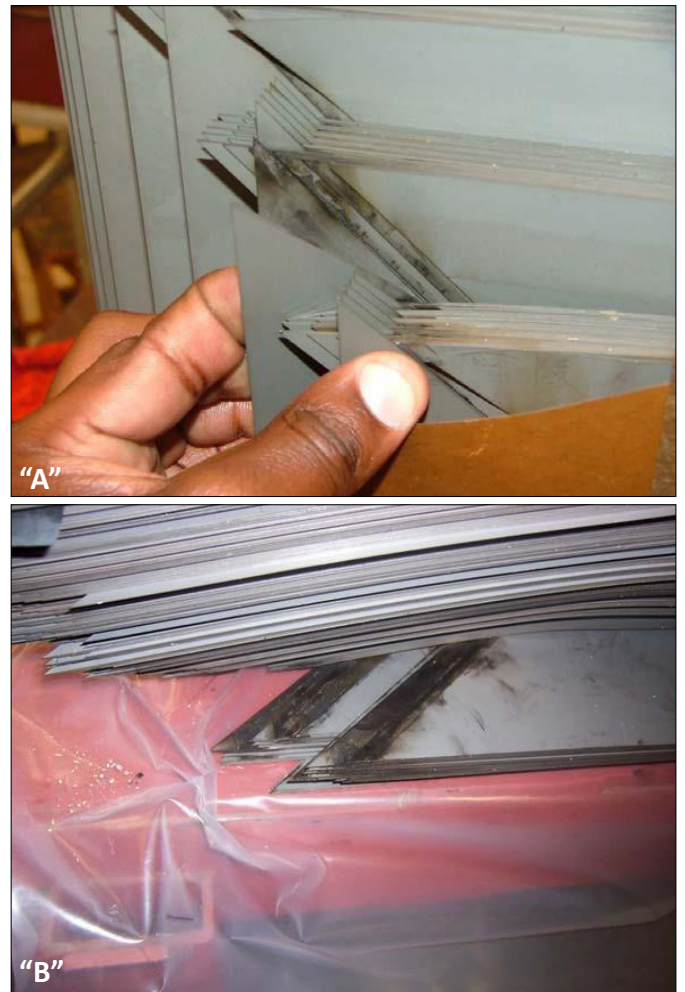
Figures 10 (A) and (B): The core overheating. A is T21 and B is T22

- Striking resemblance of core defect between T22 and T21 (See Figure 10)
- Caused by stray magnetic fields induced by high currents on LV winding
- Field interaction with core at overlapping joints causes local heating
- Local heating gives rise to gassing

Root cause of gassing was attributed to a poor shielding design or reduced cross sectional area of core.
