Dissolved Gas Analysis (DGA) role in Improving the Reliability of Wind Farm Transformers in Southern Africa.

I.A.R Gray
Oilwatch Transformer Services
South Africa
ian@oilwatch.co.za

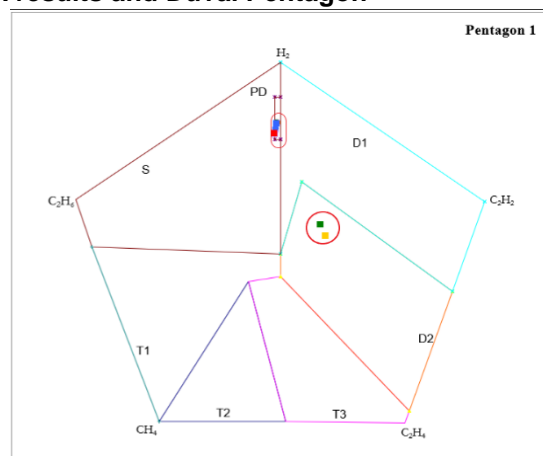
Table 2 : Partial record of the DGA results and Duval Pentagon

The case of a Pad Mount Transformer WTG 2.7 MVA, 33 kV, without OLTC. Installed in 2016, it had regular DGA sampling performed from Energisation with high dissolved gas. A partial record of the DGA results is shown in Table 2 with the Duval Pentagon plot.

Interpretation of these results using the Duval pentagon's, initially showed a Partial Discharge fault (PD), but following maintenance in July 2017 the fault type changed to a Discharge of High Energy (D2): Table 3 gives the Transformer Assessment Index(TAI)/ Scoring Matrix (Risk)

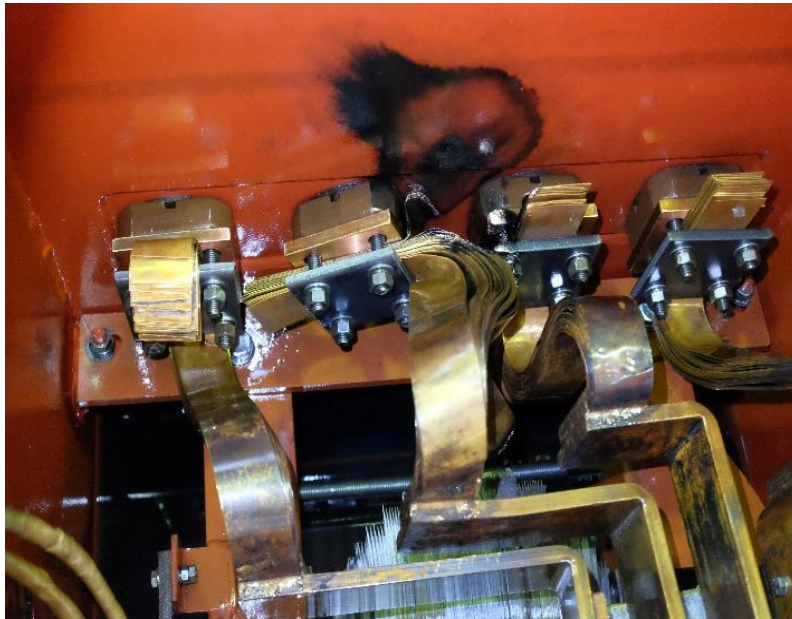
LV short circuit at the LV bushings due to a rotated bushing. It quickly burnt away the touching copper foils which was the cause for the sudden increase in hot metal gasses.

The root cause of the rotated bushing was due to improper maintenance.

The bushing had developed an oil leak and the maintenance contractor attempted to repair this by tightening the Bushing on the outside of the transformer. (Figure 1)

Figure 1 : LV short circuit at the LV bushings due to a rotated bushing

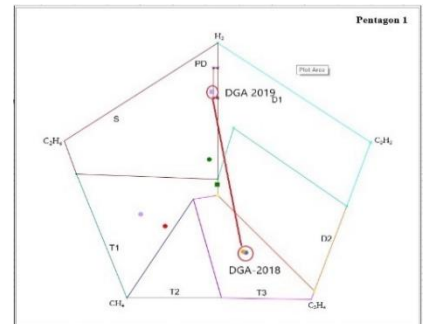
Table 5 : Partial record of the DGA results and Duval Pentagon Plot

The case of a Pad Mount Transformer WTG 2.7 MVA, 33 kV, without OLTC. Installed in 2016, it had regular DGA sampling performed from Factory Acceptance Testing (FAT) to site energisation with all results showing normal operation. However, the sample taken 3 months after Energisation on load showed high dissolved gas, A partial record of the DGA results is shown in Table 5 with Duval Pentagon plot.(Thermal Fault-T3)

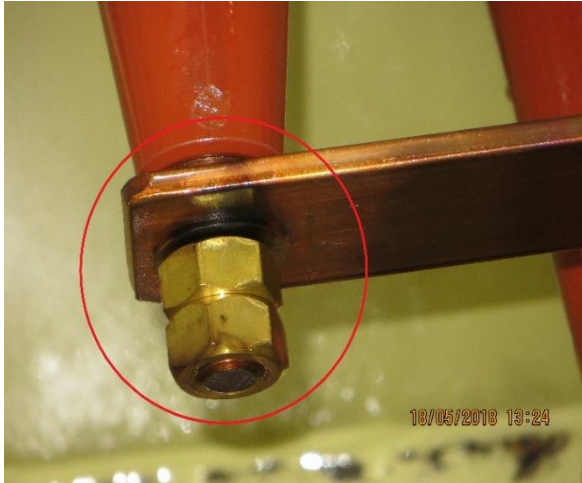
The In-warranty inspection found a burnt connection on the 33 kV Bus bar link. (Figure 2) Non-conforming quality control (factory oversight). The first nut was not fastened but the 2nd lock-nut was tightly torqued.

The reason the gas levels increased even though the transformer was de-energised, was the 33kV Links remains energised even when the Isolator is opened to power up the rest of the network. (Daisy chain configured)

Figure 2: burnt connection

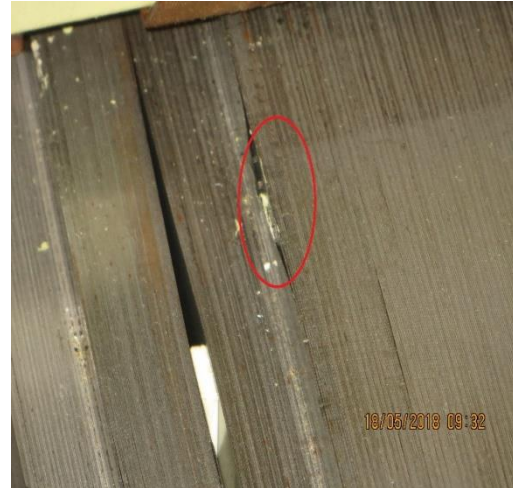
A Secondary fault observed on the Core which will contribute to Hysteresis loss and Eddy currents. (Figure 3) and is most probably the cause of the gassing seen in the sample dated 2019/06/10.

Figure 3: Secondary fault observed on the Core

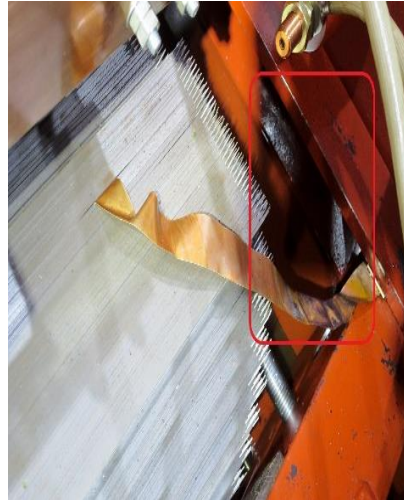
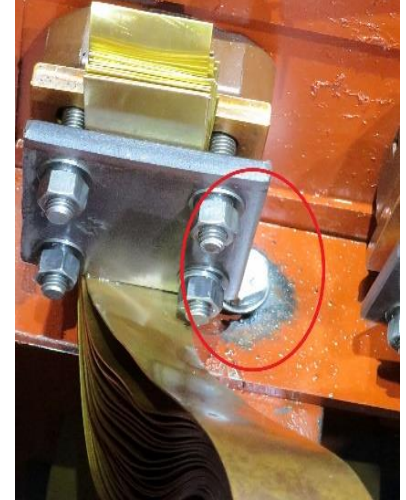
Note: The abnormal gassing pattern was evident after Energisation on load, (Warranty issue)

The internal inspection revealed a number of quality issue, figures 5 & 6 show some of the faults.

Figures 5 & 6 : Findings of the Internal Inspection:

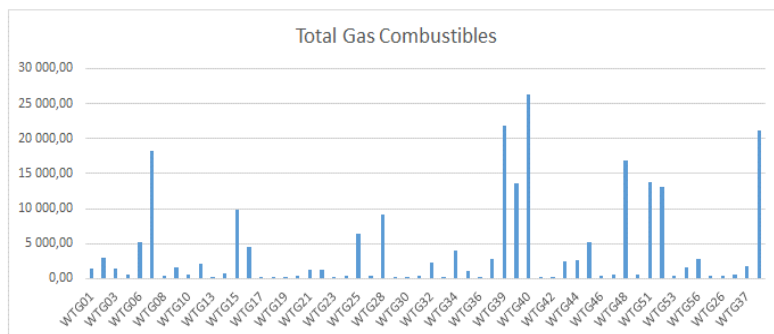
In this Case Study of 55 Transformers at a Windfarm, the Dissolved Gas Analysis (DGA), showed a significant number with Abnormal Gas levels when compared to sister Units, as seen in Figure 7. The fault category in most cases was Partial Discharge activity. According to CIGRE 761 Assessment Index (TAI) Scoring Matrix (Risk), the results are given in Table 7 of Transformer scored as Category D: E: F, while figure 8 shows the Gas Signatures.

Figure 7: Comparison of Totable Combustible Gas (TCG) concentrations

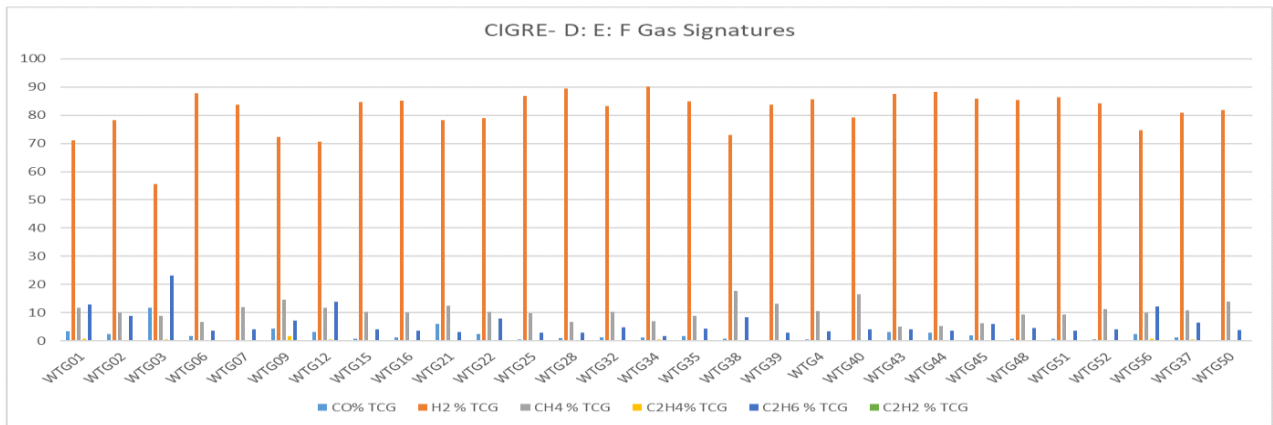
Figure 8: Dissolved Gas Signatures (CIGRE Category D: E: F)

The main cause of the PD was identified as sharp edges on the foil windings as well as bad workmanship in the factory exacerbating the PD due to stop-blocks damaging the paper. The process followed to properly cure the diamond dotted paper had not been followed correctly resulting in the paper not curing to the foil properly or even at all. Harmonics was also a role player.
