Dissolved Gas Analysis (DGA) role in Improving the Reliability of Wind Farm Transformers in Southern Africa.

Ian Gray

Oilwatch Transformers Services

11th
REGIONAL
CONFERENCE
POWER SYSTEM TECHNOLOGIES FOR
SUSTAINABLE GROWTH IN AFRICA

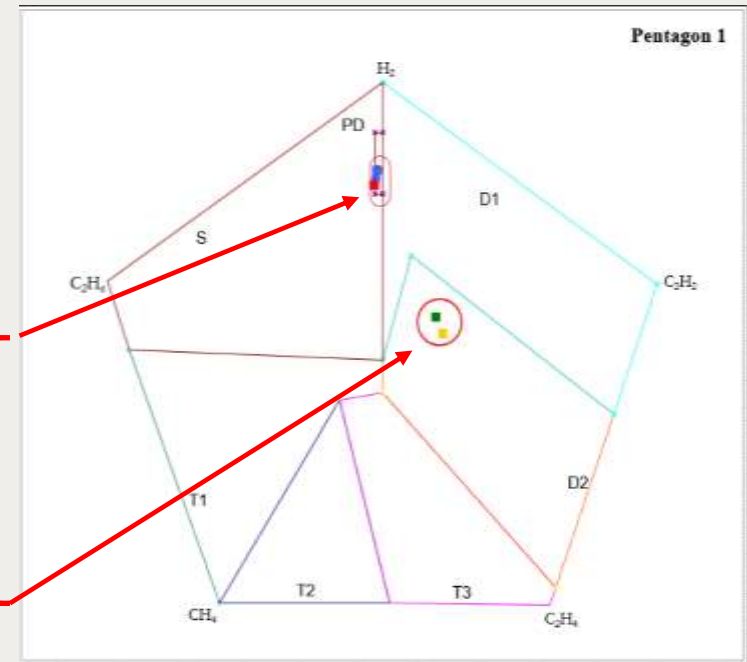
Case Study WTT 2.7 MVA, 33 kV Installed in 2016

- A partial record of the DGA results with the Duval Pentagon plot.
- initially a Partial Discharge fault (PD), but following maintenance in July 2017 the fault type changed to a (D2) Discharge of High Energy

Date	H ₂	CH ₄	C ₂ H ₂	C ₂ H ₄	C ₂ H ₆
2016/06/07	2942	329	0	6	54
2016/10/12	6857	574	0	6	95
2016/11/02	11908	1232	0	12	276
2016/11/07	12310	1050	0	9	180
2016/11/15	14697	1244	0	13	260
2016/11/23	10710	1329	0	13	276
2017/02/10	13208	1625	0	13	375
2017/06/05	15333	1362	0	8	297
2017/08/14	2463	1047	2256	1569	301
2017/09/01	3169	1063	2237	1566	309

Transformer Assessment Index (TAI) Scoring Matrix (Risk)	TAI	Remedial Action
Very Poor condition – high likelihood of failure. Component is near end of life. Repair or replacement as soon as possible is recommended. De-rating or restricted operation of the transformer may be appropriate, and operation under extreme conditions may not be appropriate until replacement is possible.	E	Resample DGA weekly to monitor Gas Rates of Rise-Plan to remove from service for Inspection/Repairs.

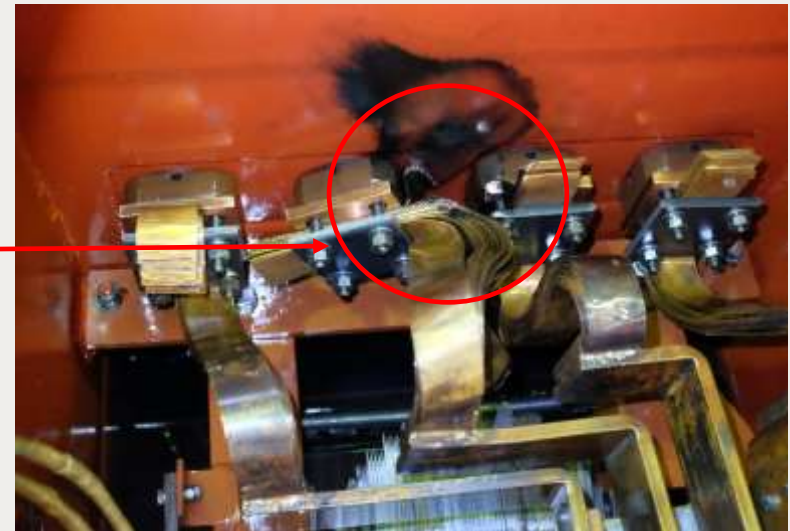
- **Internal Inspection**
- LV short circuit at the LV bushings due to a rotated bushing. It quickly burnt away the touching copper foils which was the cause for the sudden increase in hot metal gasses
- root cause of the rotated bushing was due to improper maintenance

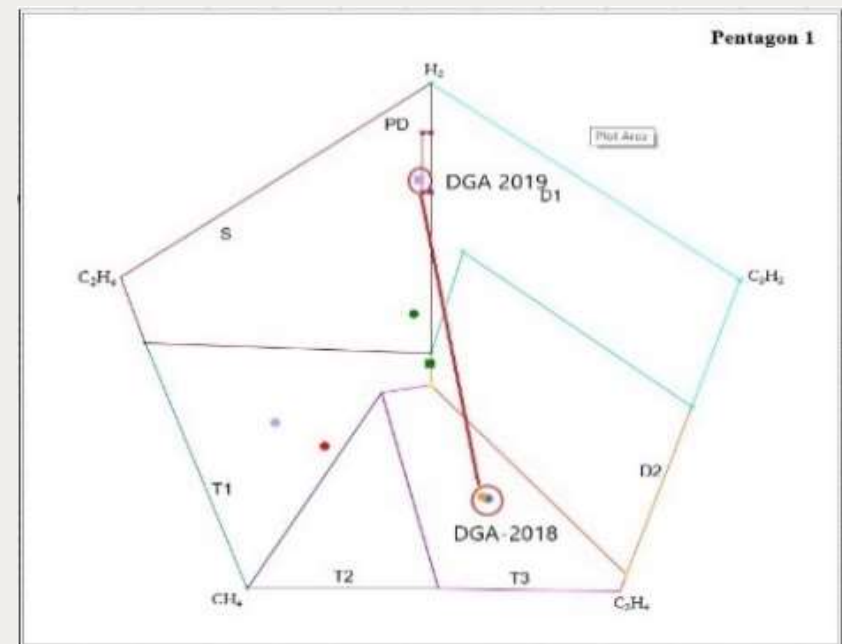
Case Study WTT 2.7 MVA, 33 kV Installed in 2016

- Regular DGA sampling performed from Factory Acceptance Testing (FAT) to site energisation with all results showing normal operation.
- 3 months after Energisation significant Gas rise.
- DGA results shown in Table with Duval Pentagon plot.(T3 Fault)-2018
- 2019-Partial Discharge (PD) fault

Date	H ₂	CH ₄	C ₂ H ₂	C ₂ H ₄	C ₂ H ₆	Type
2017/06/22	0	3	0	1	5	Prior to energising
2017/12/01	0	4	0	1	4	
2018/01/20	0	4	0	2	3	
2018/04/23	1253	9341	1887	27952	4077	
2018/05/10	2300	12264	2163	33951	4949	
2018/10/08	9	4	1	3	3	Prior to Re-energising
2019/06/10	7737	720	2	87	308

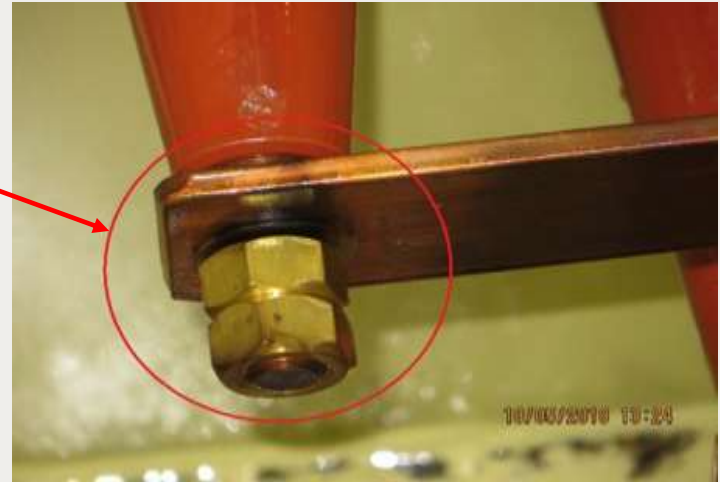
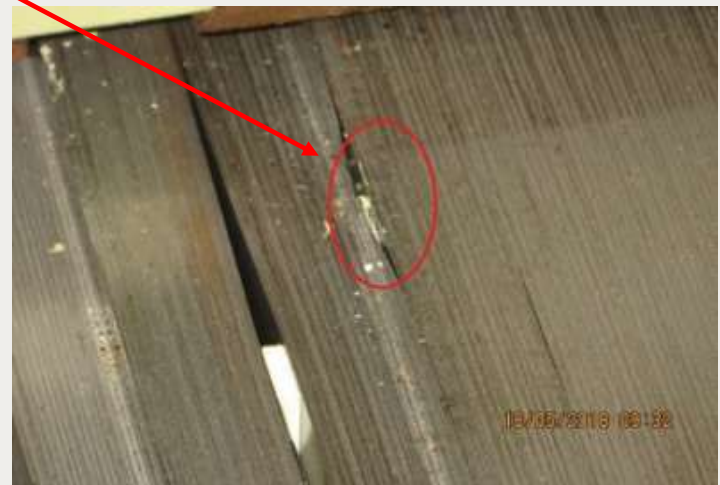
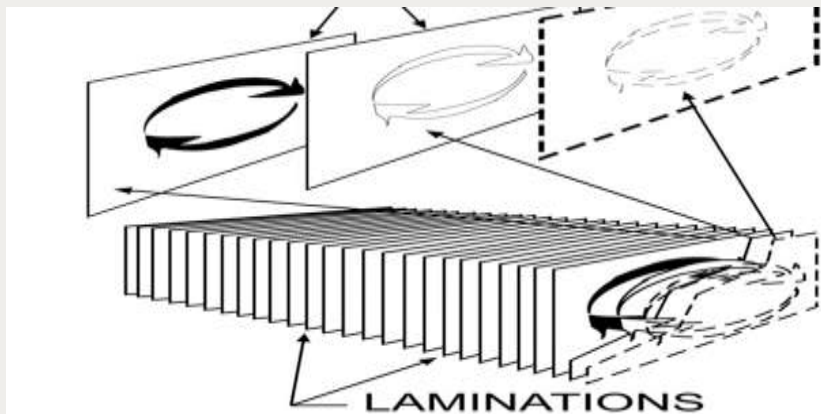
Internal Inspection (Root cause Investigation).

- In-warranty inspection found a burnt connection on the 33 kV Bus bar link.
- (Non-conforming QC)
- Secondary fault observed on the Core which will contribute to Hysteresis loss and Eddy currents(PD)-DGA 2019

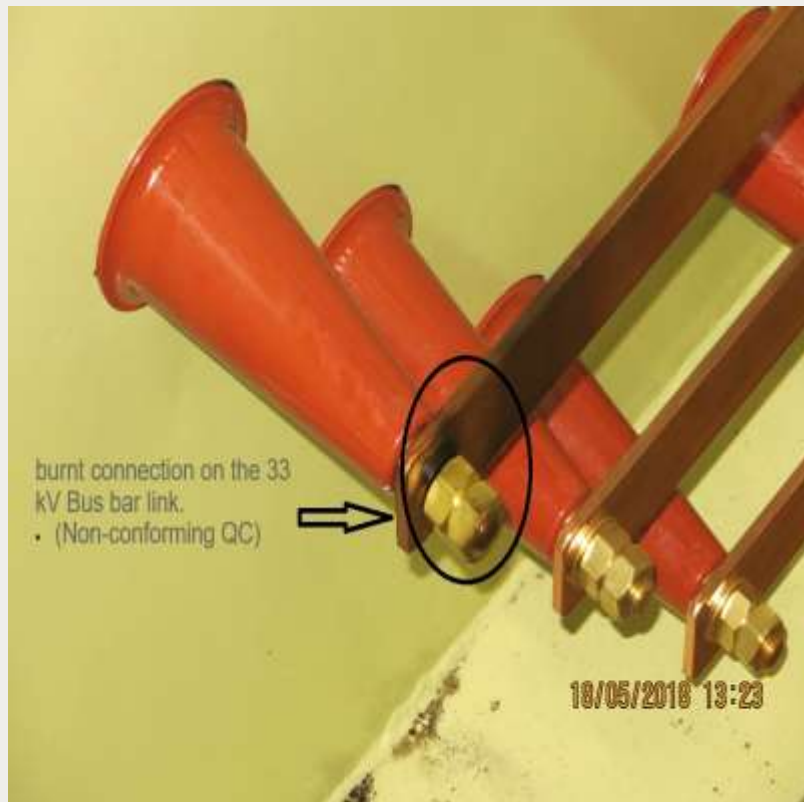
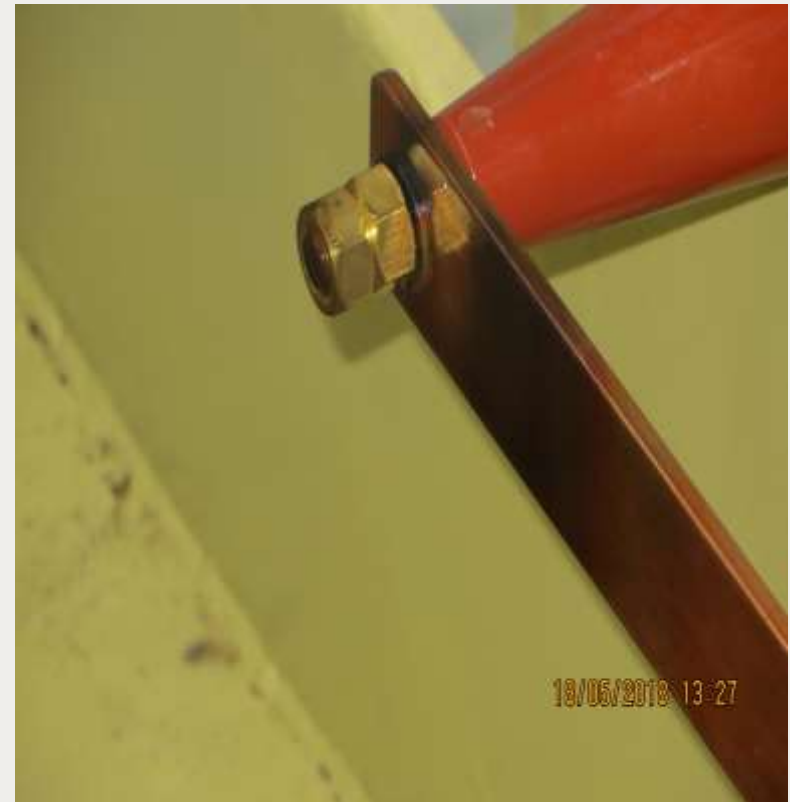
OEM Inspection

- **Burning connection 33 kV Bus bar link**

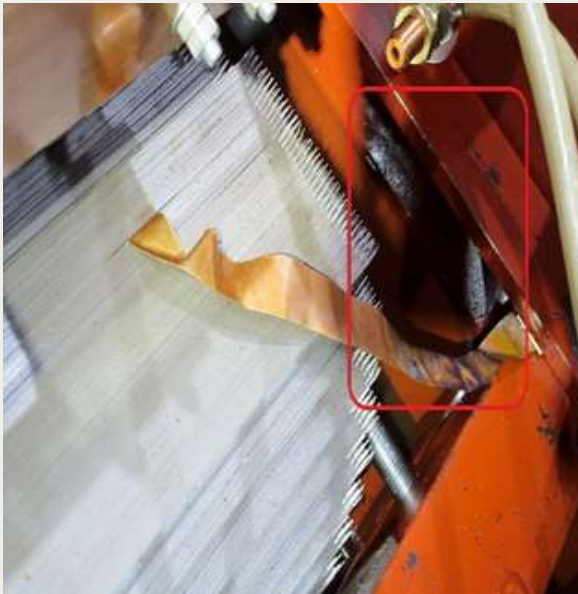
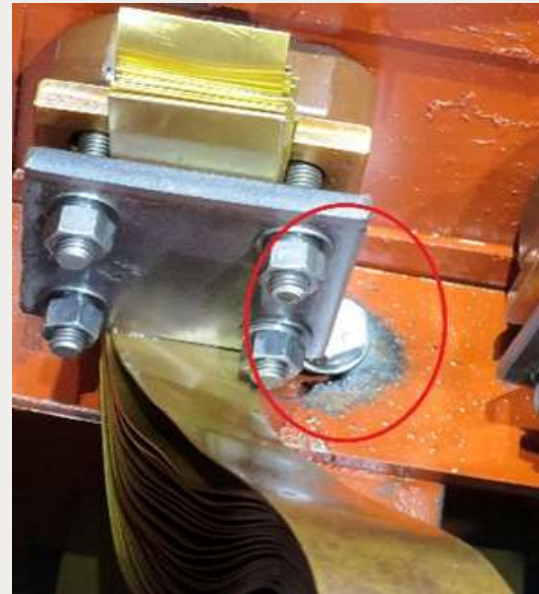
Findings of the Internal Inspection

- The internal inspection revealed a number of quality issues

- Large circulating currents in tank and core
- Minor currents in tank walls created by a high uncompensated magnetic field
- Shorting links in core steel laminations

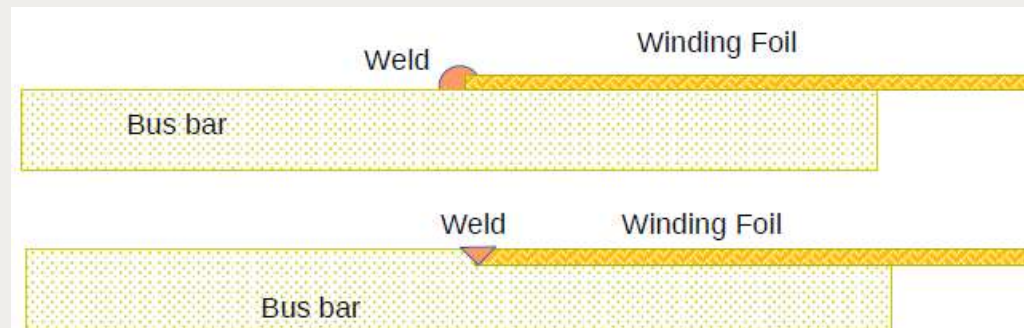
- PD was identified as sharp edges on the foil windings as well as bad workmanship in the factory exacerbating the PD due to stop-blocks damaging the paper. Harmonics was also a role player.
- One major reason for hydrogen formation due to PD in this transformer type is bad manufacturing procedures.
- Consequently, most transformer manufacturers should be aware that asperities must be avoided even in transformers with low voltage level.

Lower schematic drawing
show a better design, low in asperities and thus causing less PD.
