Practical Experience Gained from Dissolved Gas Analysis at an Aluminium Smelter

As Presented at EuroTechon 2011

This paper will provide a summary of Hillside Smelter Transformer faults detected by Dissolved Gas analysis at Early Life

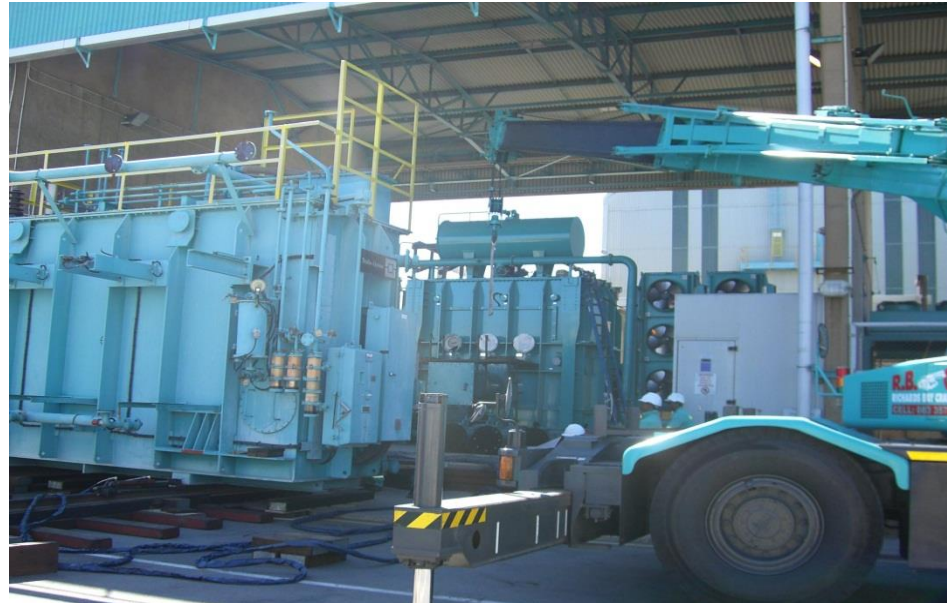
The root cause was found to be a weakness in the Regulator transformer design.

The manufacturer had to change the design to an External 22kV Reactor for each Regulator transformer

Also one additional Transformer Bay was required for Potline 1 and 2 at a cost of approximately R 70 Million per transformer bay

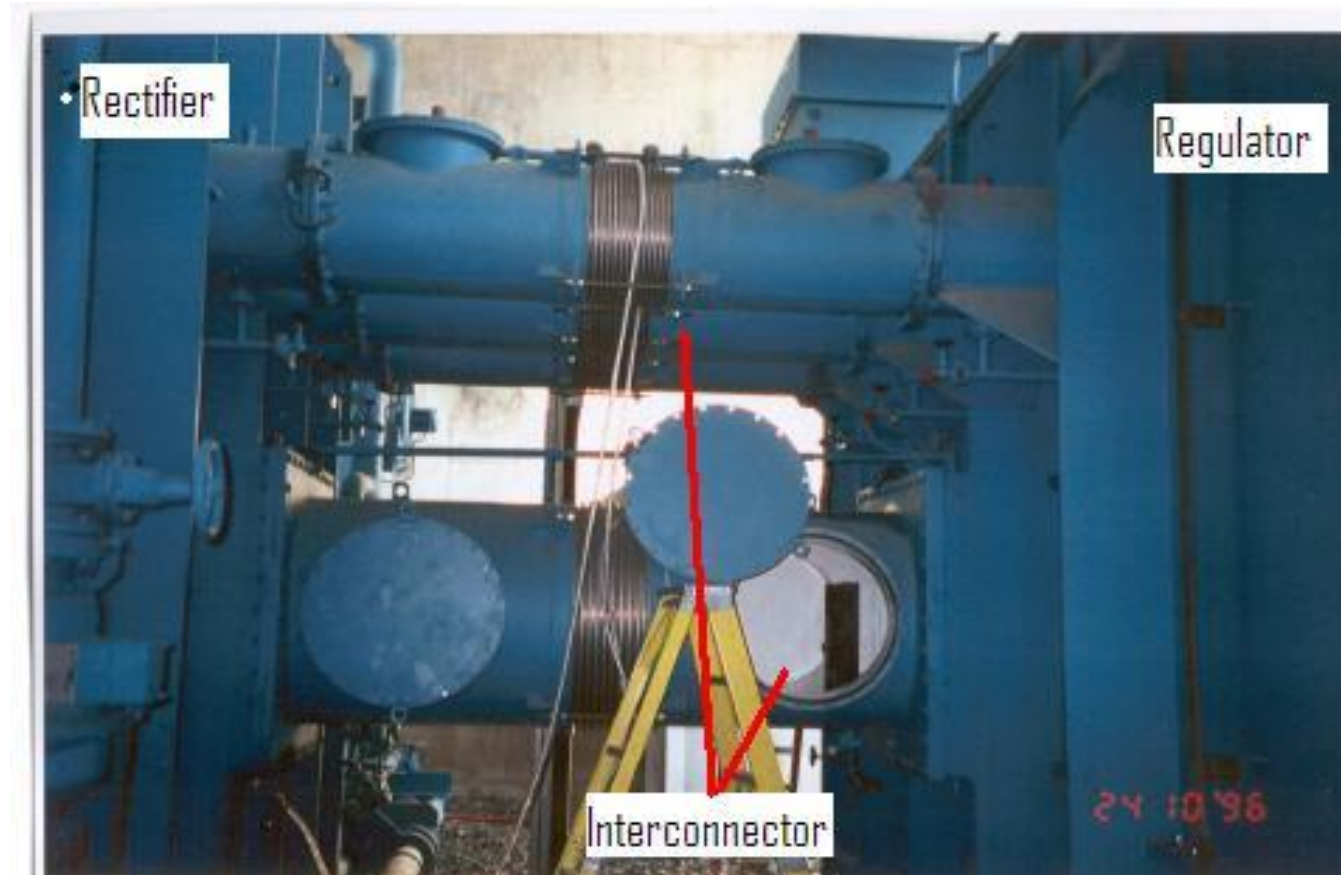
On the 23rd October 2005, a gas alarm was triggered by the Buchholz relay

The OEM suspected a Corona (Partial Discharge-PD) problem on the Cable housing

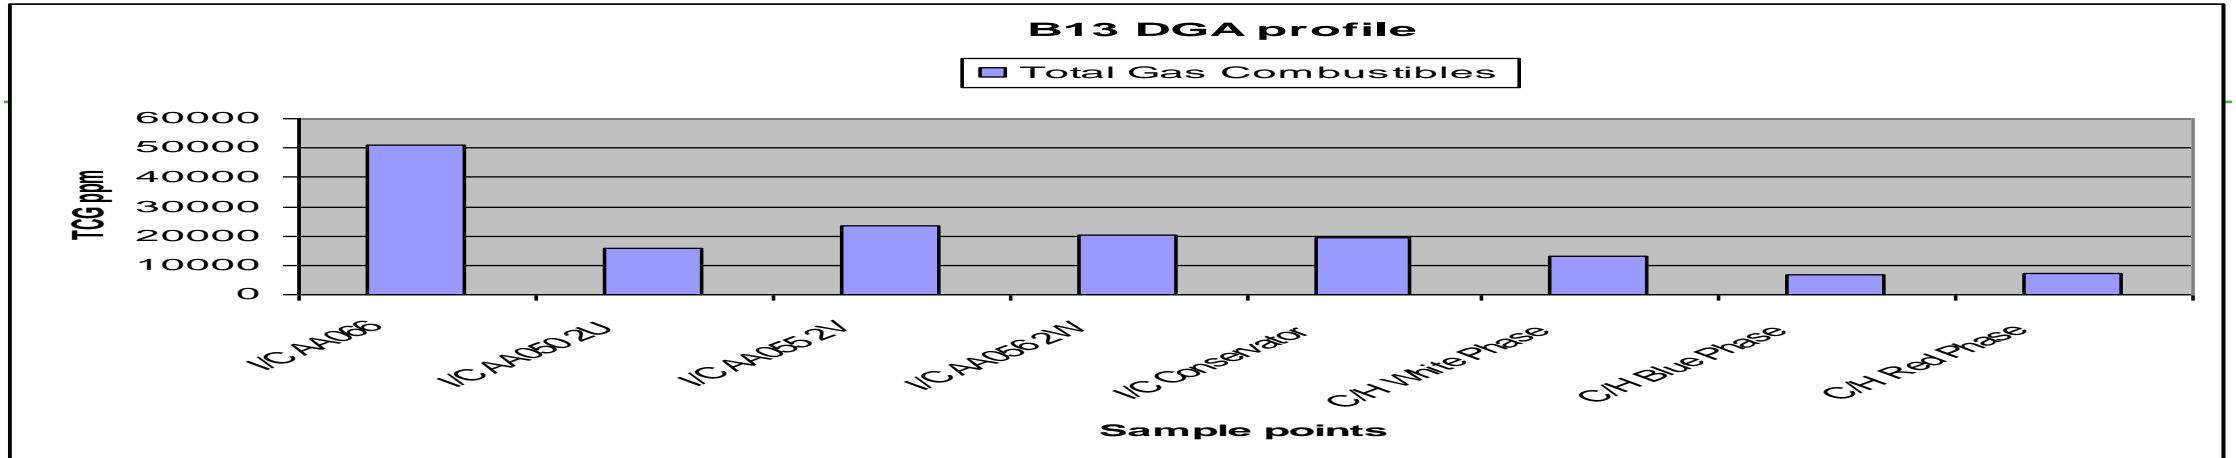
DGA profile of samples

IEC 599 DIAGNOSIS: **Thermal fault of medium temperature range 300°C-700°C**

IEEE (c57.104-1991): **Condition Code 4:**
OPERATING PROCEDURE-
Exercise extreme caution. Plan outage.

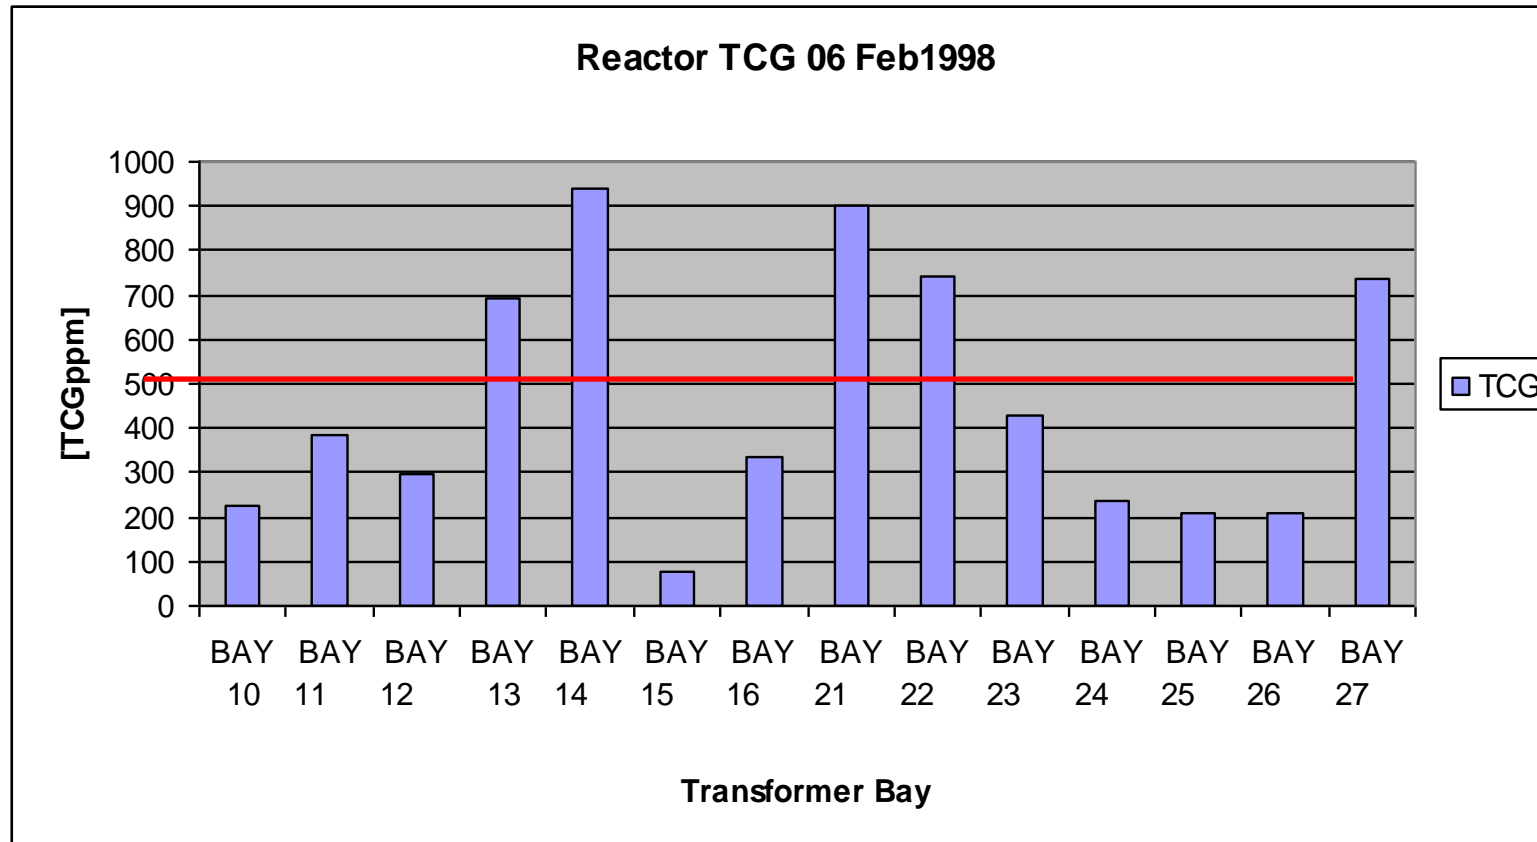
Routine DGA samples taken on 06/02/1998 showed a significant increase of Total Combustible Gas in a number of Reactors

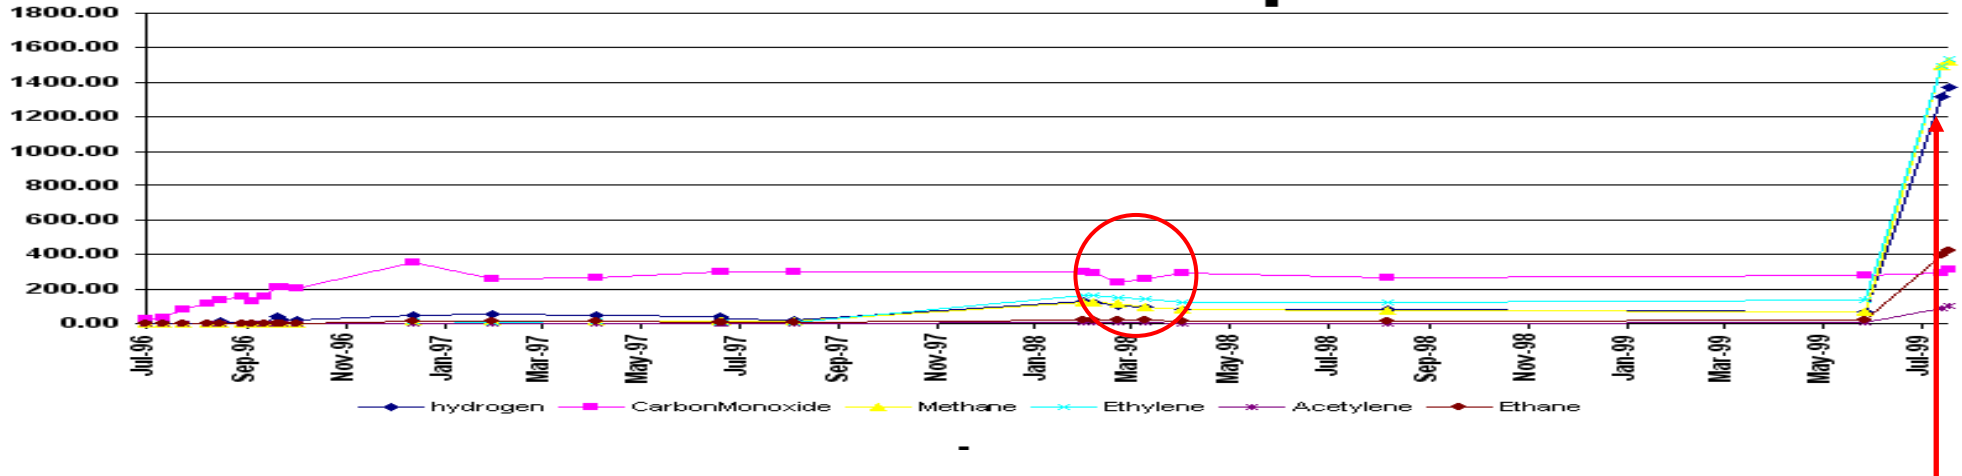
BAY 22 Reactor Transformer

IEC 599 Ratio: Thermal fault of high temperature range >700°C.

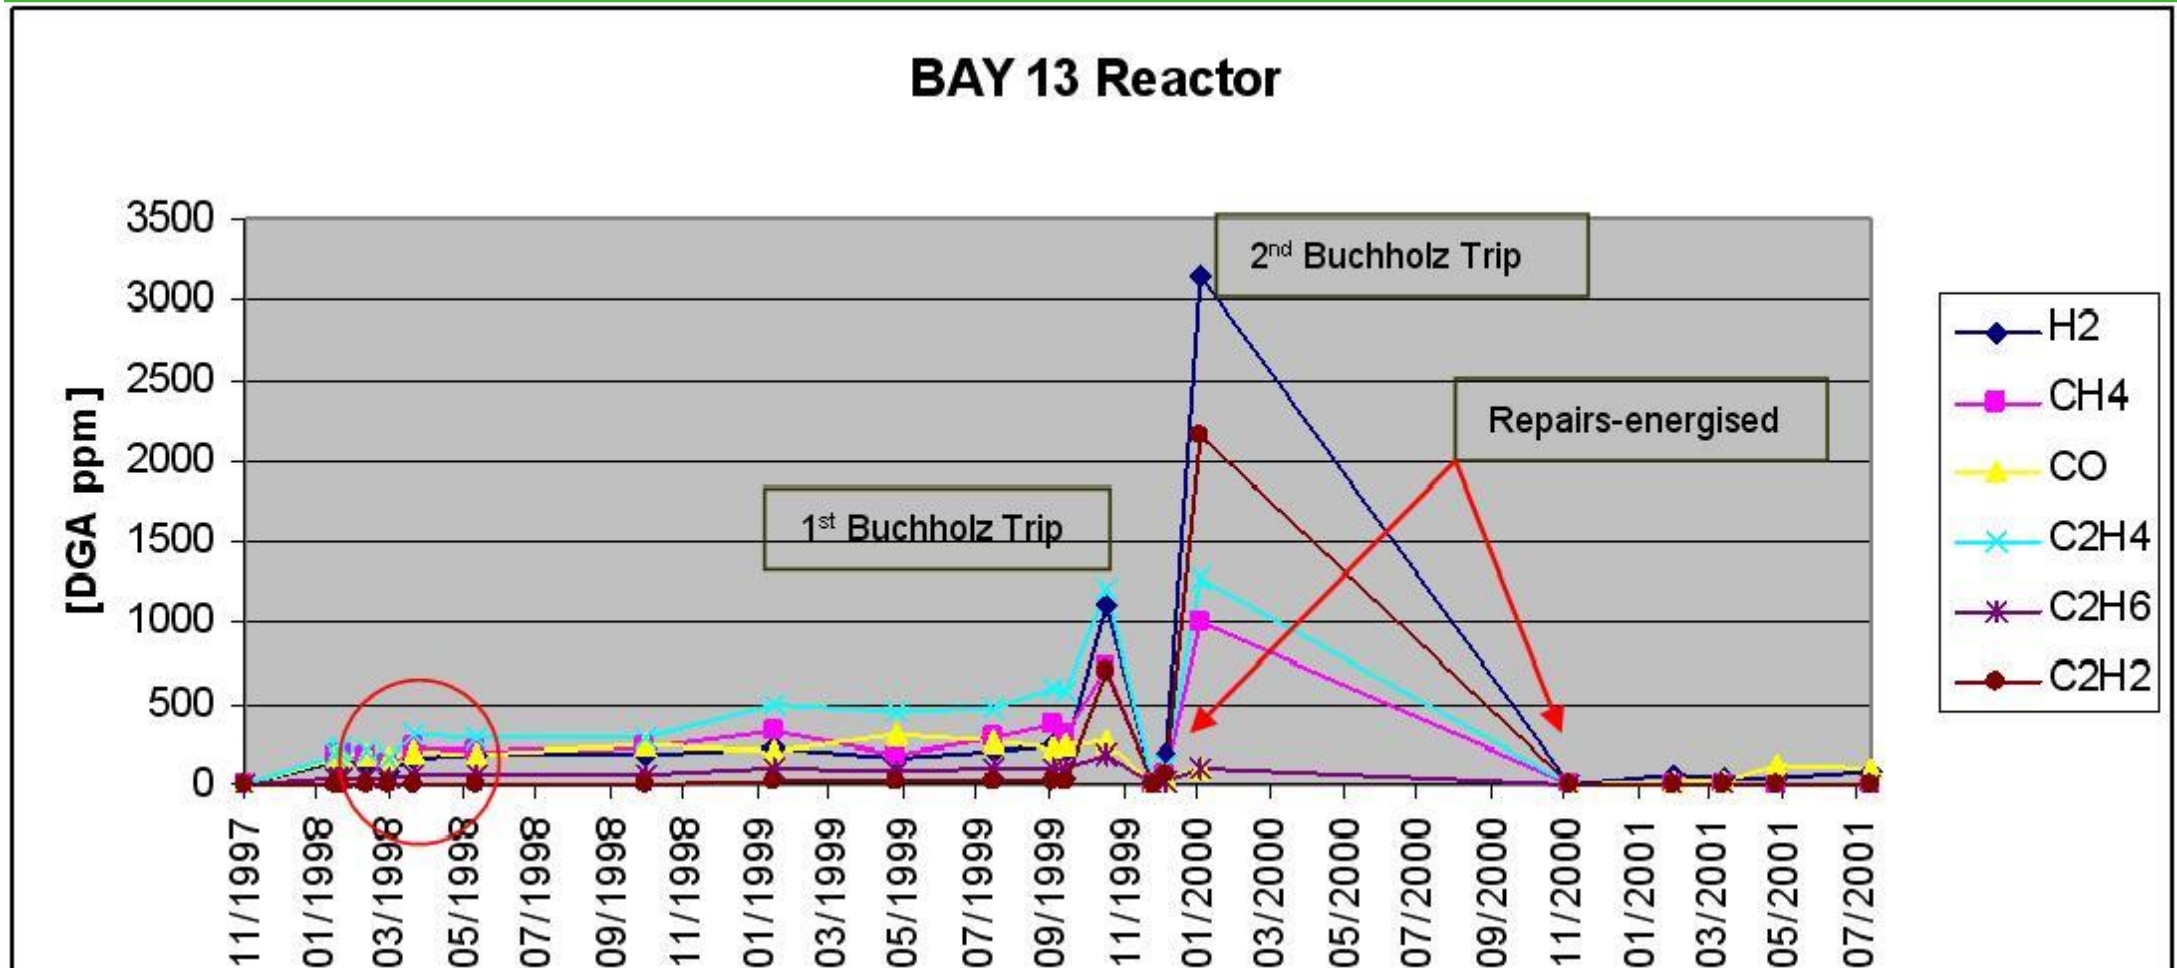
BAY 13 Reactor Transformer

Fifth Harmonic being amplified within the transformer causing it be subjected to 10 times its rated current for a couple of milli-seconds. Design fault involving the power factor correction. (Weakness in design).

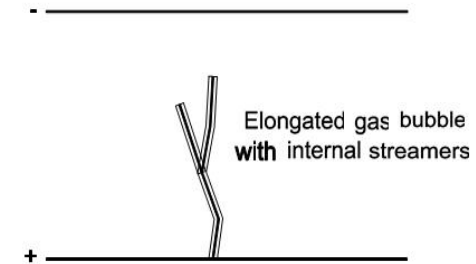
Mechanism of the flash-over-voltage stress caused gas bubble formation.

Gas bubbles elongate in the direction of the electric field

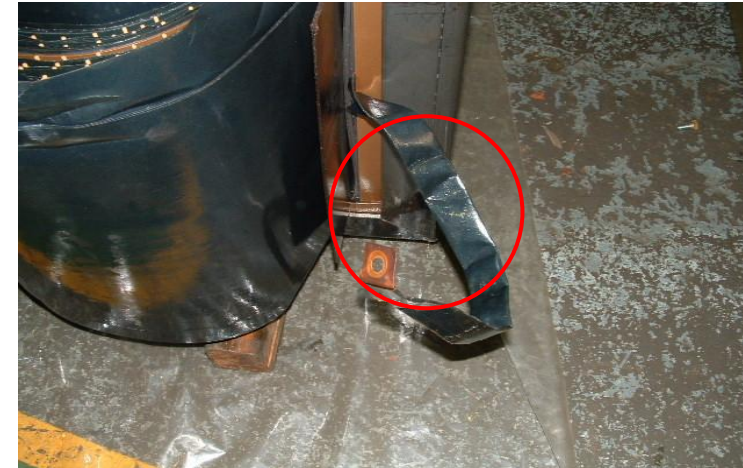
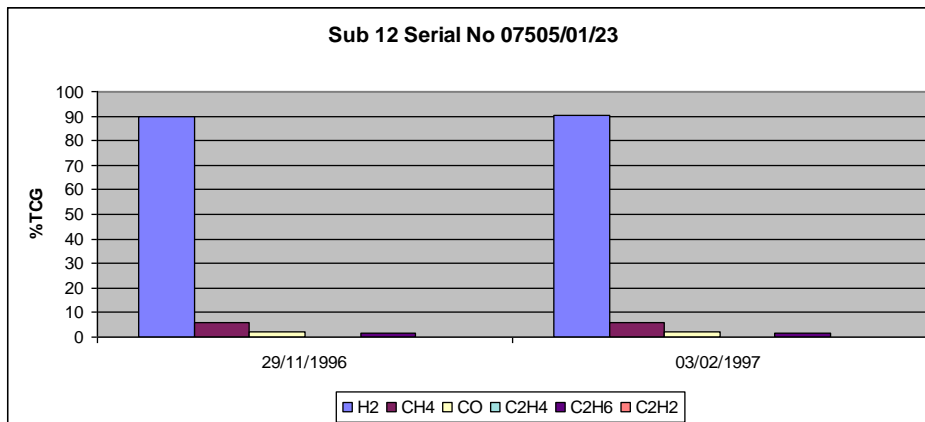
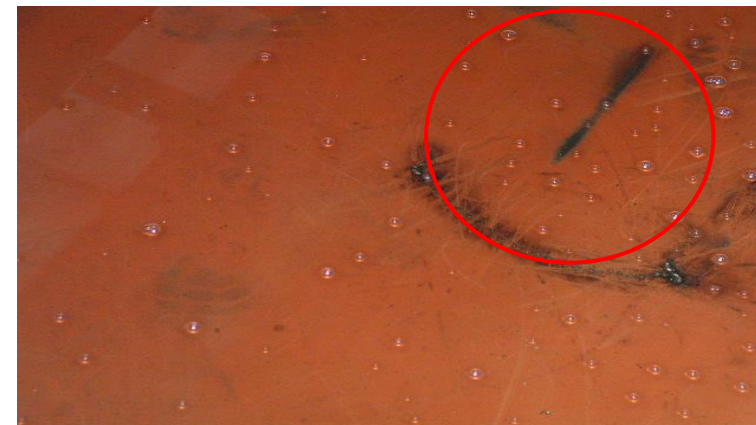
Loose internal earth strip

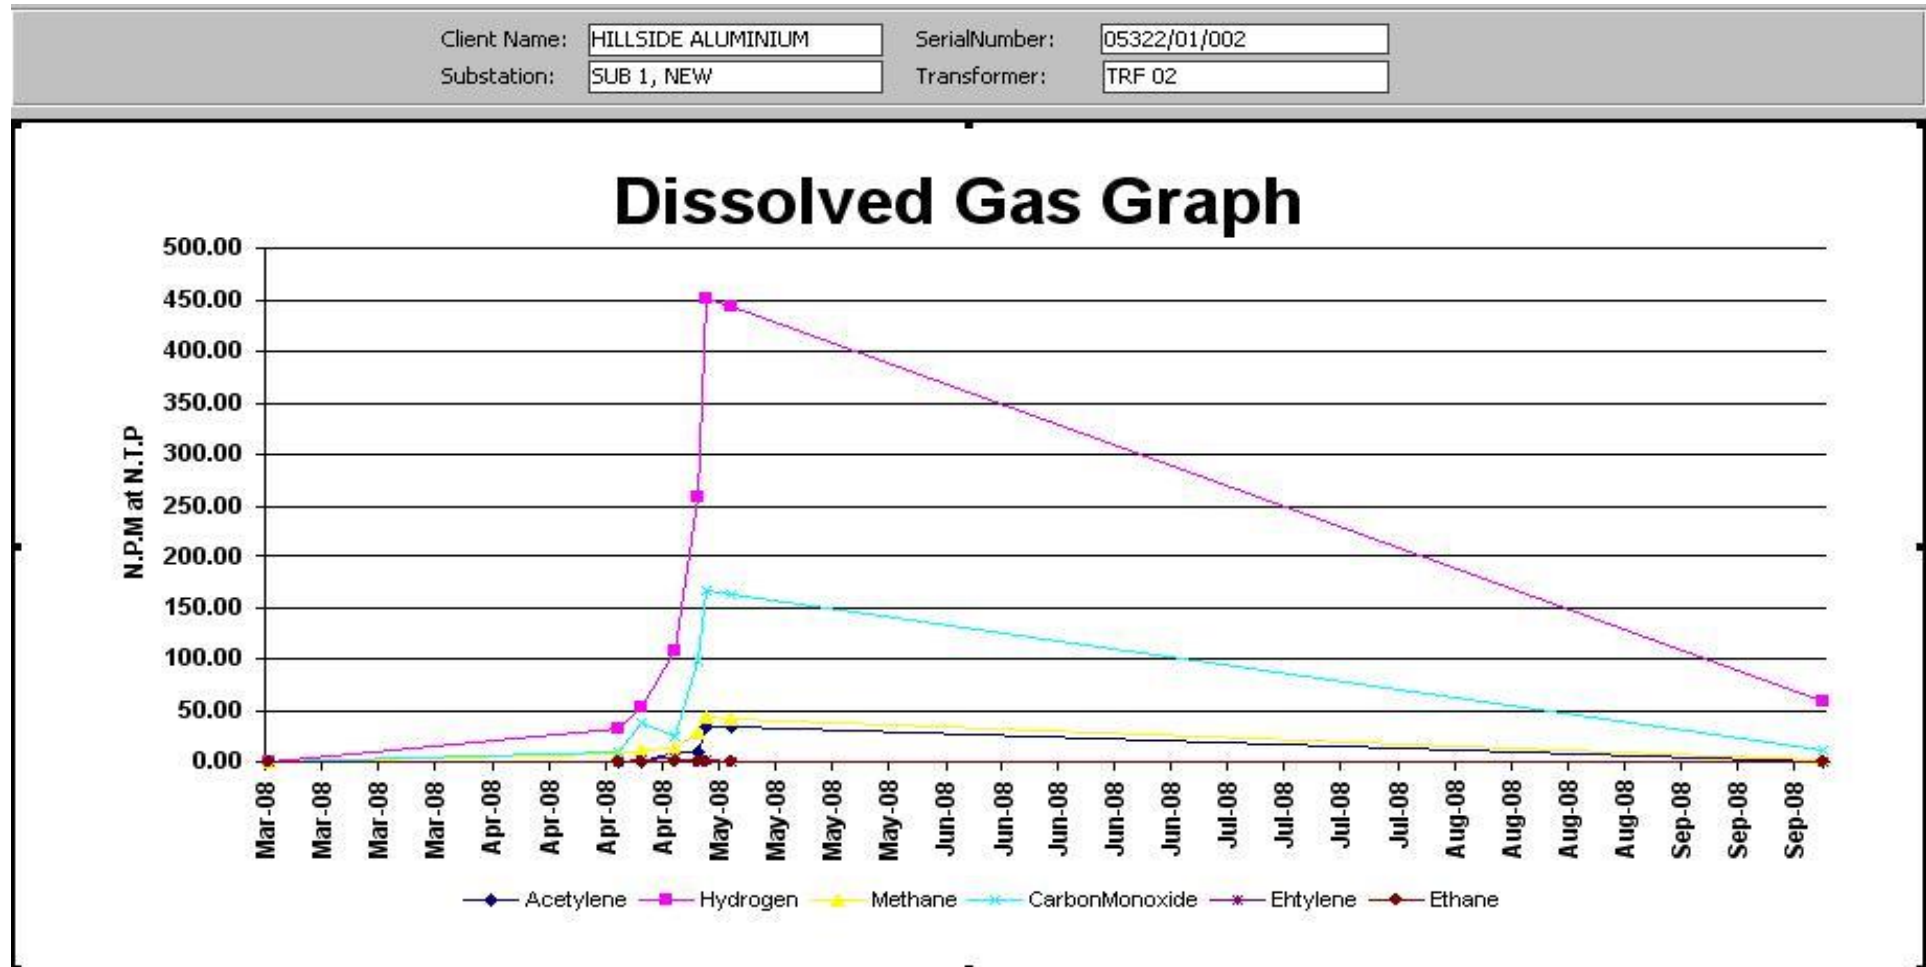
Case 2: Partial Discharge in 22 kV Transformers predicted by DGA

The root cause was established to be weakness of design and non-conforming quality control during manufacture.

Savings: The transformers were repaired under warranty.

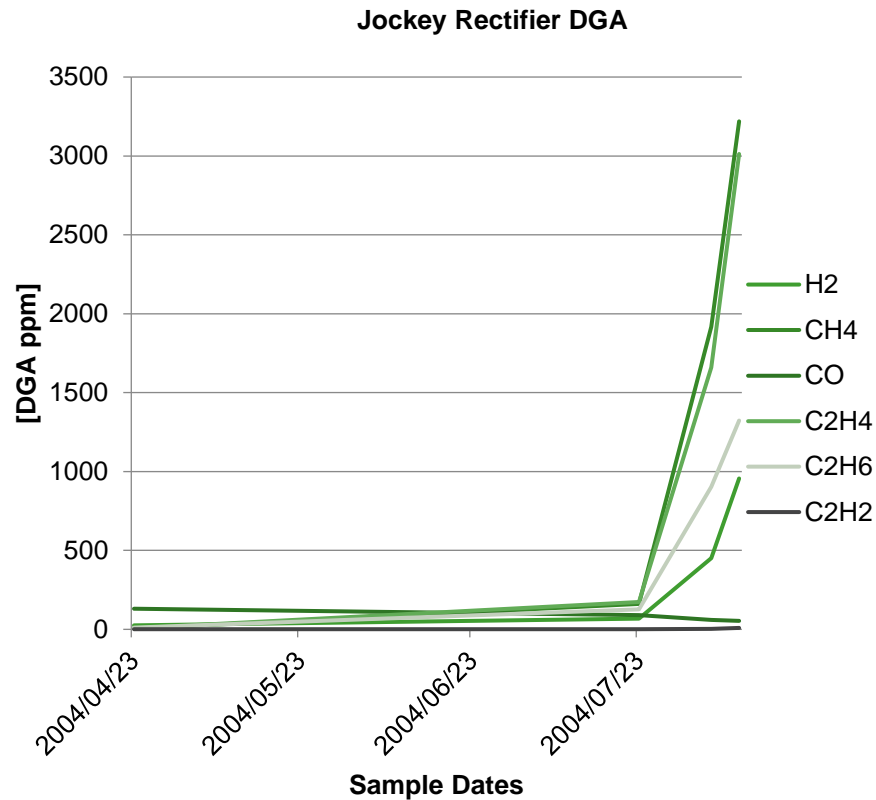
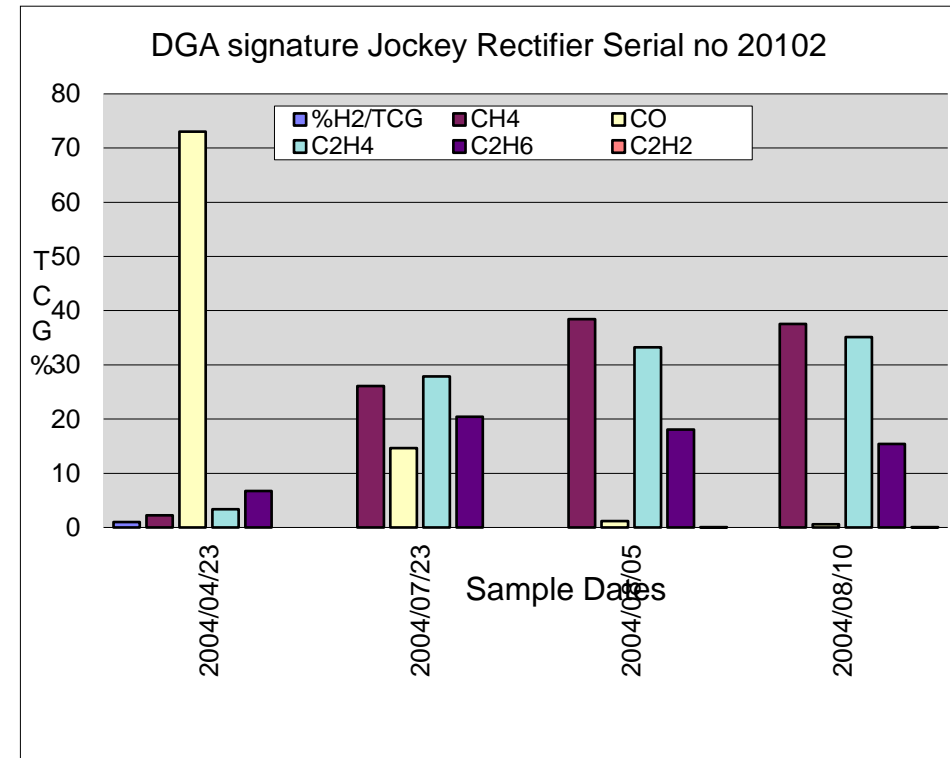
Case Example : Jockey Rectifier Transformer

The DGA on this transformer showed abnormal gas production of H₂ CH₄ C₂H₄ and C₂H₆ about 3 months after Energisation

Termination for potential connection became a hot spot due to circulating current

The transformer was repaired at a works facility under the warranty of the OEM.

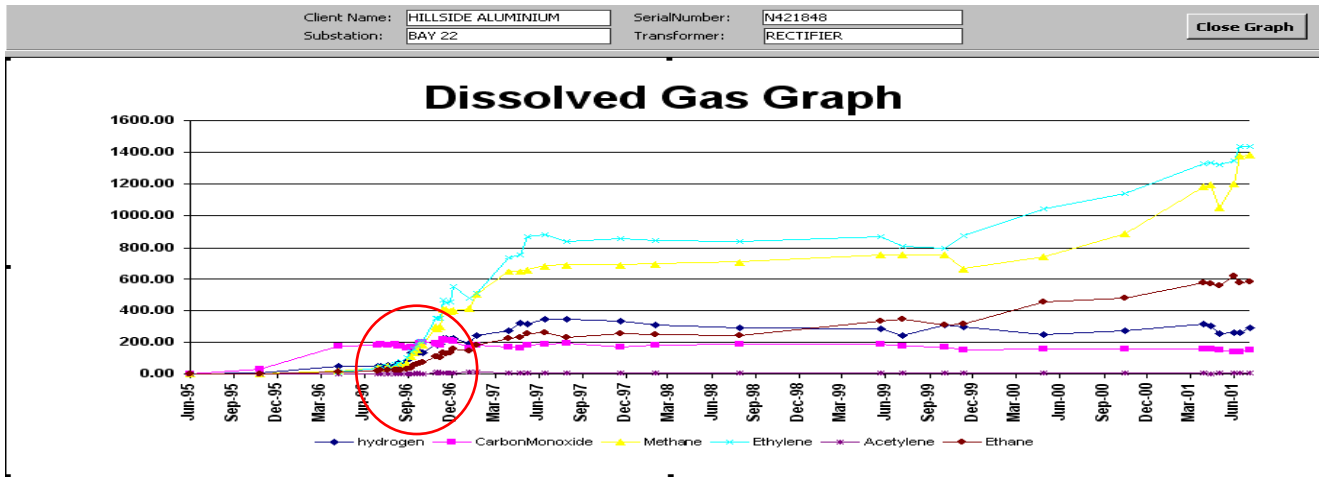
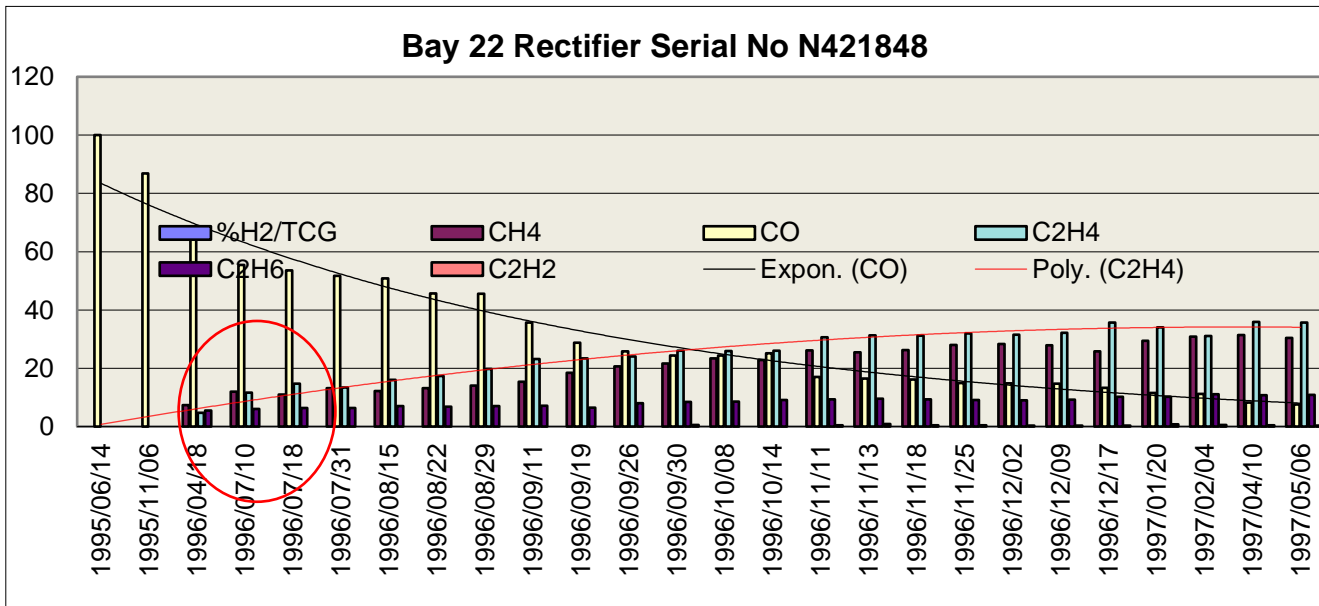
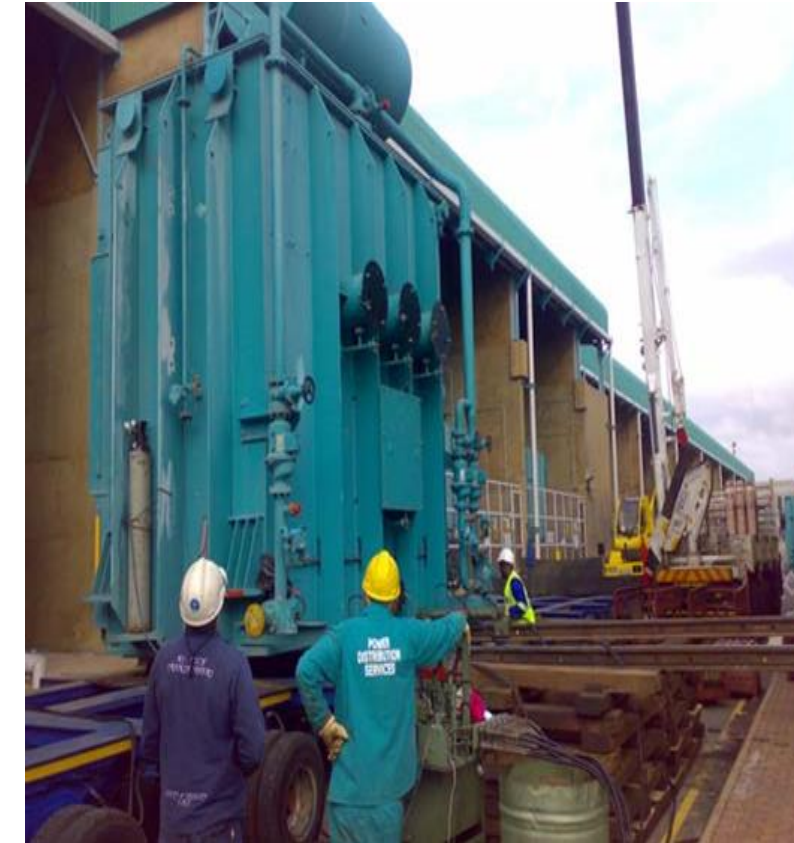
T22 Transformer Failure-93.5 MVA

The DGA on this transformer showed abnormal gas production of H_2 , CH_4 , C_2H_4 and C_2H_6 about 20 months after Energisation

This transformer was ranked as having the highest risk of failure, based on the DGA-
Total Combustible Gas profile

The condition was monitored by regular oil samples. On-line DGA was considered

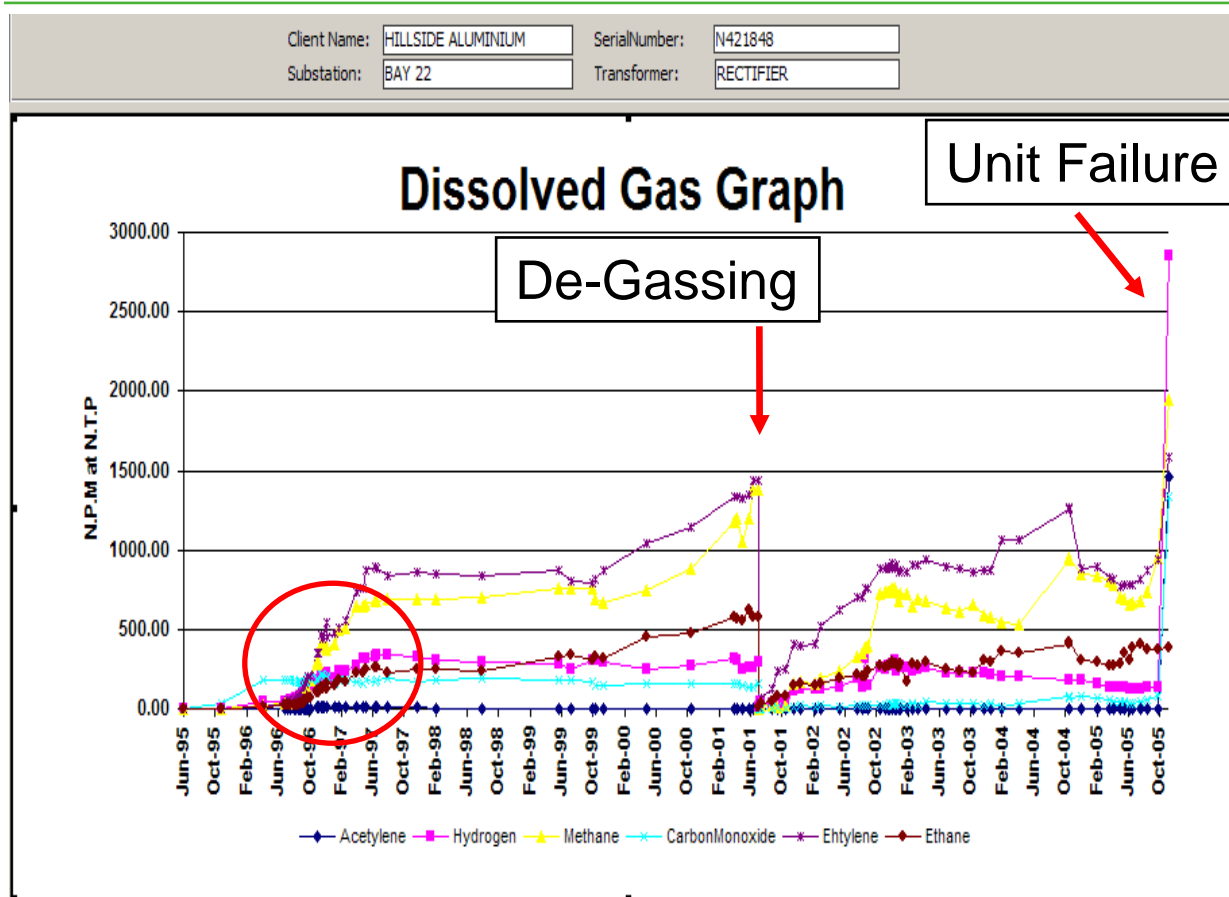
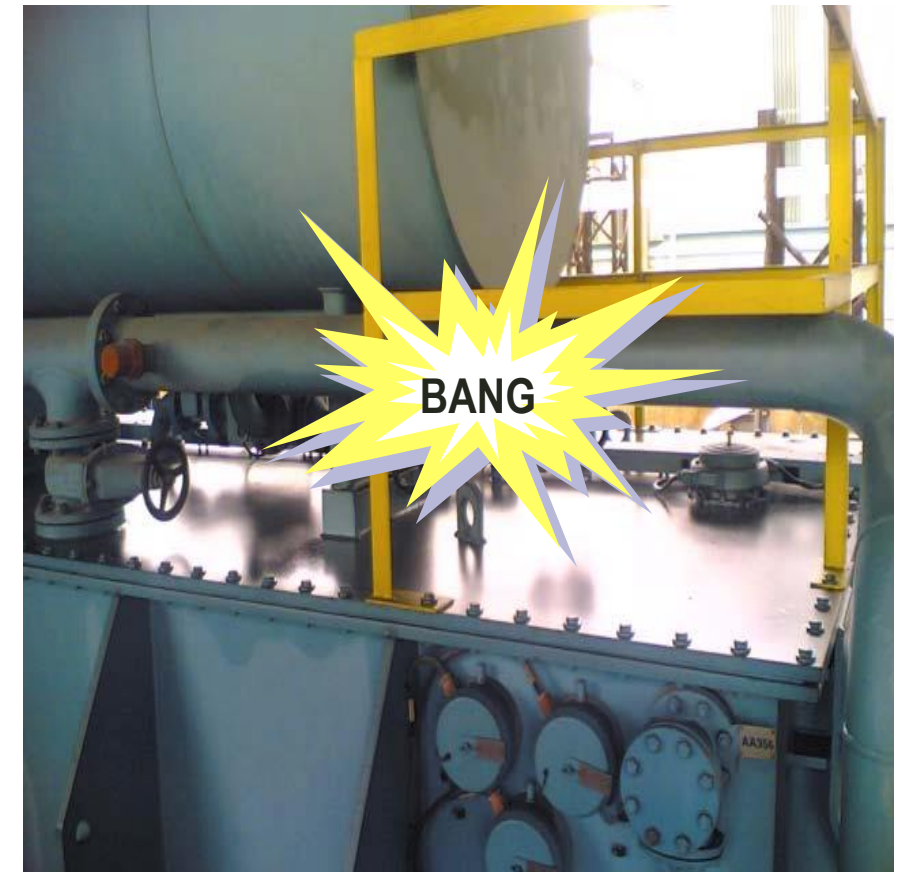
Failure Event At 16:32, on the 18 November 2005, Transformer T22

- When T22 transformer failure developed, the entire sequence of events, equipment failures and trips were over in **approximately one second.**

- 900 MW wiped off the National Grid
- Potline 1 offline for 75 min
- Potline 2 offline for 145 min

- Major impact to Production (output and process stability)
- Damage to critical Control circuits
- Loss of N-1 redundancy in Transformer Supply

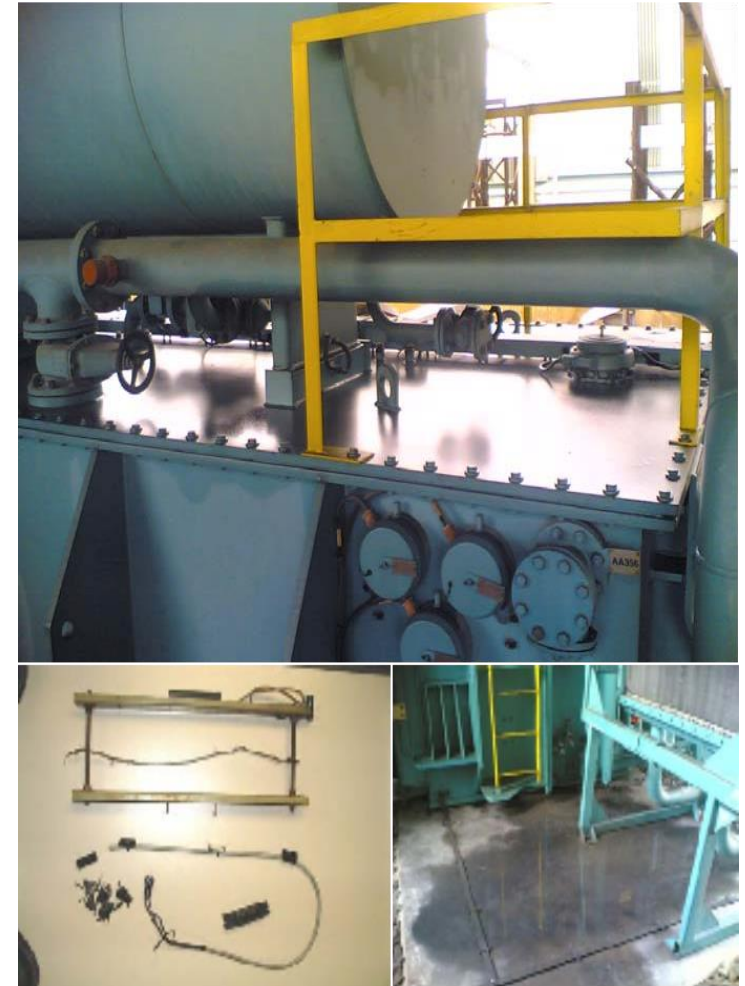
High Voltage winding open circuit and flashed to core

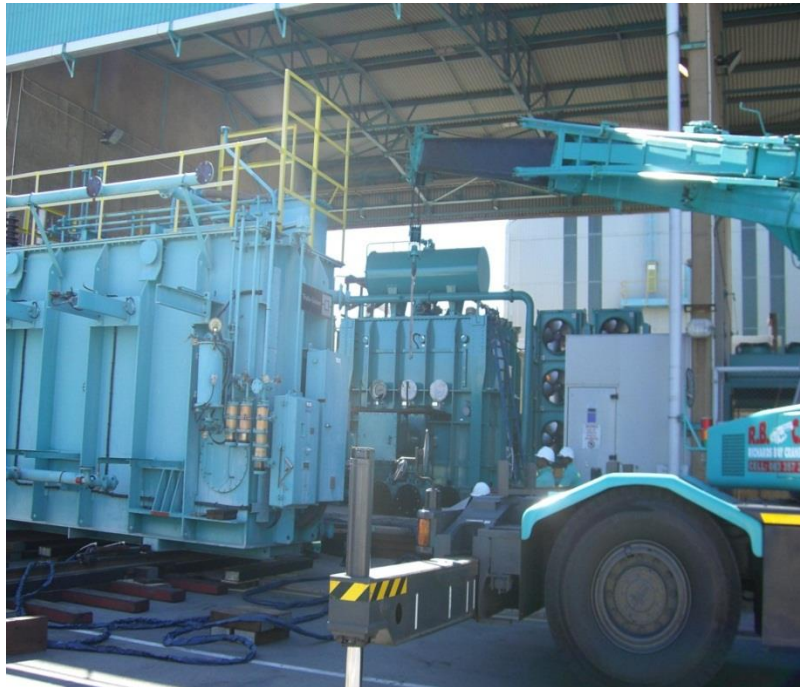
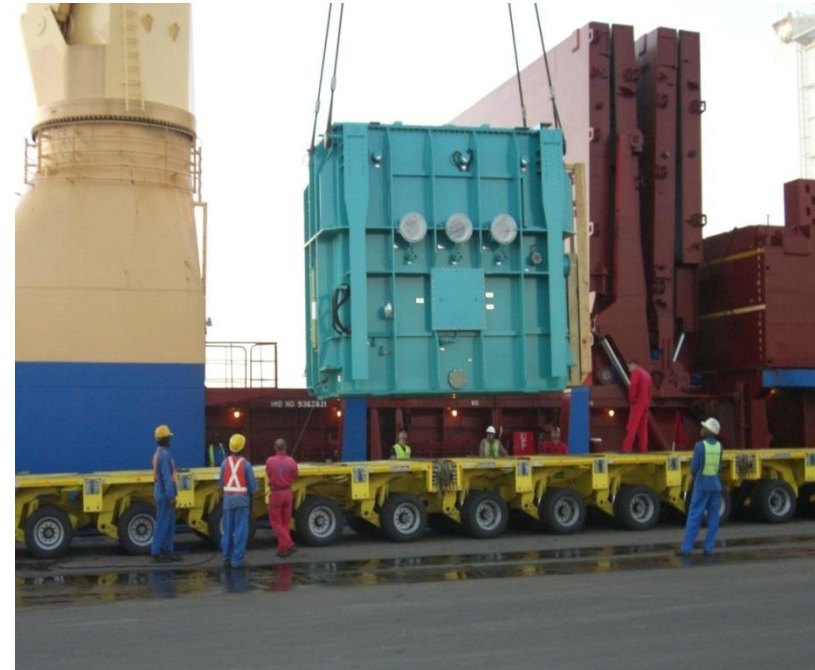
- Root cause of gassing was attributed to a poor shielding design or reduced cross sectional area of core
- Early retirement of all Rectifiers of this design.
- On Line DGA monitors installed
