Practical Experience Gained from Dissolved Gas Analysis at an Aluminium Smelter

By Ian Gray(MSA Chem I No 51954 as Presented at EuroTechcon 2011

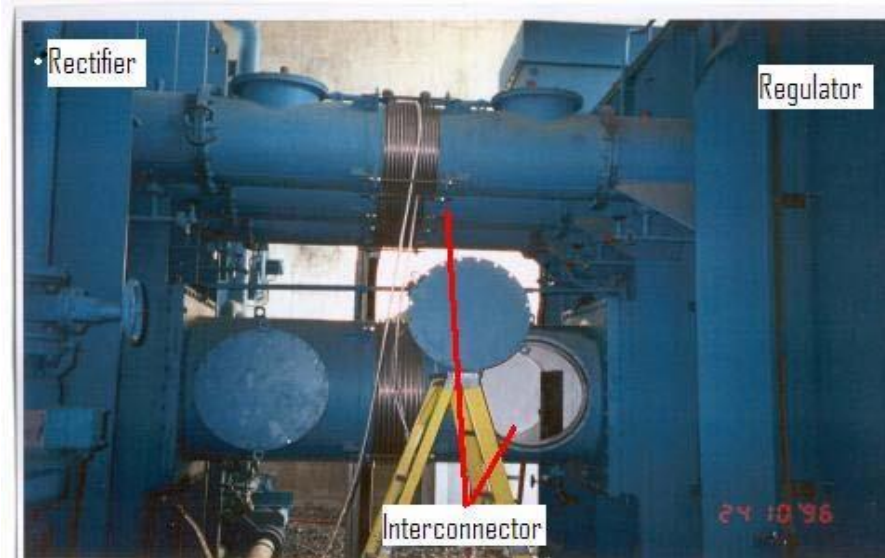
Figure 14
Interconnection system for the Rectifier and Regulator Transformers.

On the 23/10/2005, a gas alarm was triggered by the Buchholz relay on the Interconnector system. The Interconnector links the Regulator and Rectifier through a system of oil filled compartments using paper insulated copper conductor. This event occurred approximately 6 months after energisation.

See Figure 14 showing the how the Rectifier and Regulator Transformers are interconnected; the Cable Housing is to the right of picture.

The OEM suspected a Corona (Partial Discharge-PD) problem on the Cable housing to be the cause of the gas generation. The repair of this kind of fault would involve a lengthy outage with specialist staff and equipment that would have to be flown in from Germany.

There is very little oil circulation in the interconnector so in theory the fault would be in the compartment with the highest gas concentrations. The Total Combustible Gas (TCG) levels as Listed in Table 13 show clearly that the location of the fault was not in the Cable Housing but at sample point (AA066), the main compartment between the transformers.

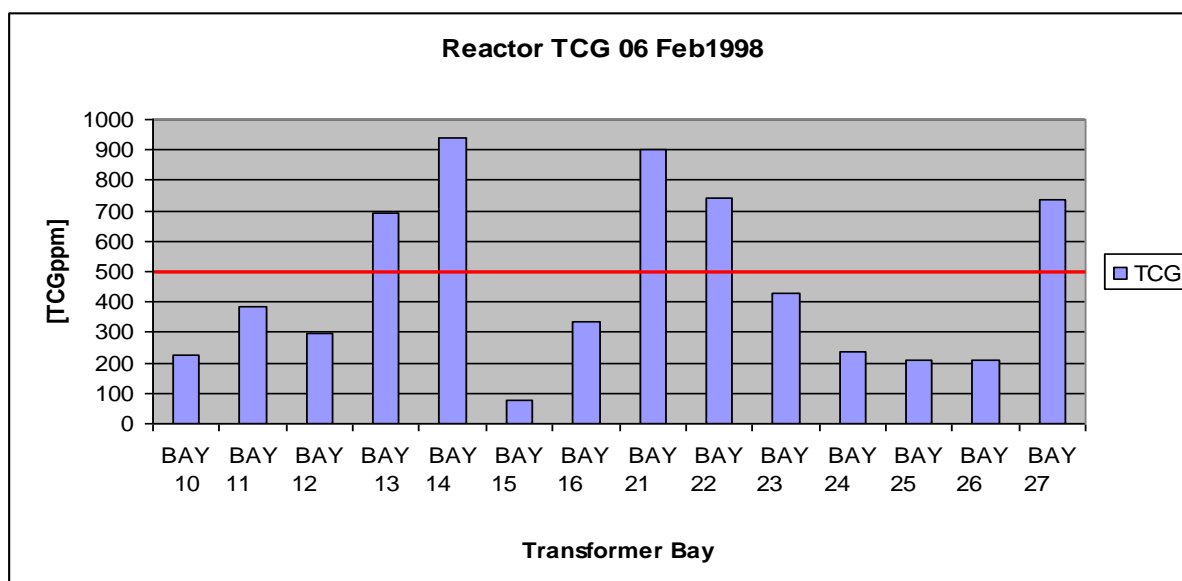
Table 16
Total Combustible Gas profile of Reactors at 06 February 1998

Routine DGA samples taken on 06/02/1998 showed a significant increase of Total Combustible Gas in a number of Reactors. See Table 16 showing the profile of results. The transformers from BAY 13: 14: 21:22 and 27 showing the most significant increases.

The IEC 599 Ratio for transformers with Combustible Gas levels >500 ppm gave the fault condition as a Thermal fault of high temperature range >700°C. The IEEE (c57.104-1991) gave a Condition Code 2 with the operating procedure in certain cases being to Advise Manufacturer or Plan outage.

It was recommended to remove one of these transformers from service for an internal inspection.

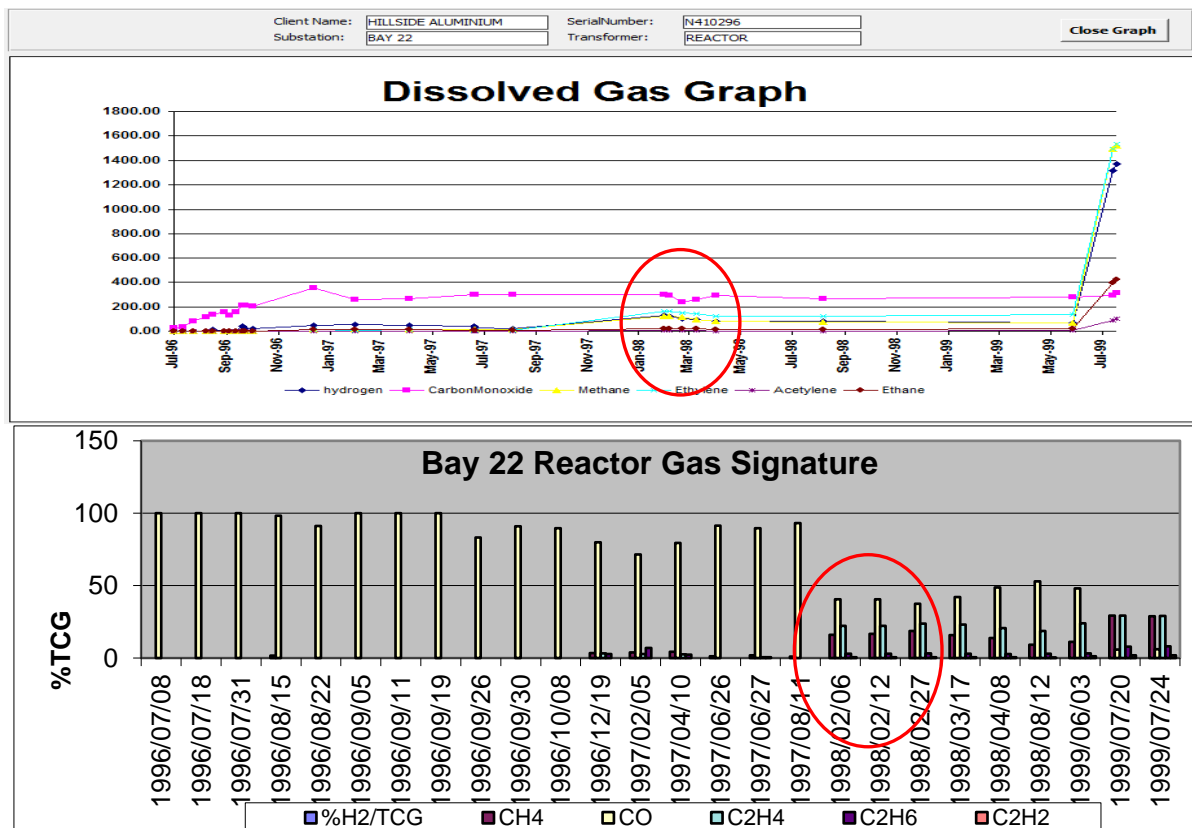
Figure 16
DGA graph trend and Signature

All the reactor transformers were sampled on a frequent basis following the significant rate of DGA rise in February 1998. The frequency of sampling was decreased when it was observed that the Dissolved Gas levels had stabilised. However a sample taken on 20th July 1999 from BAY 22 Reactor showed a more than significant increase. A further sample was taken 24th July 1999 for confirmation and to monitor the Gas production. See Figure 16 giving the Graph trend and Gas Signatures.

The IEEE (c57.104-1991) gave a Condition Code 4 with the operating procedure to plan an outage.

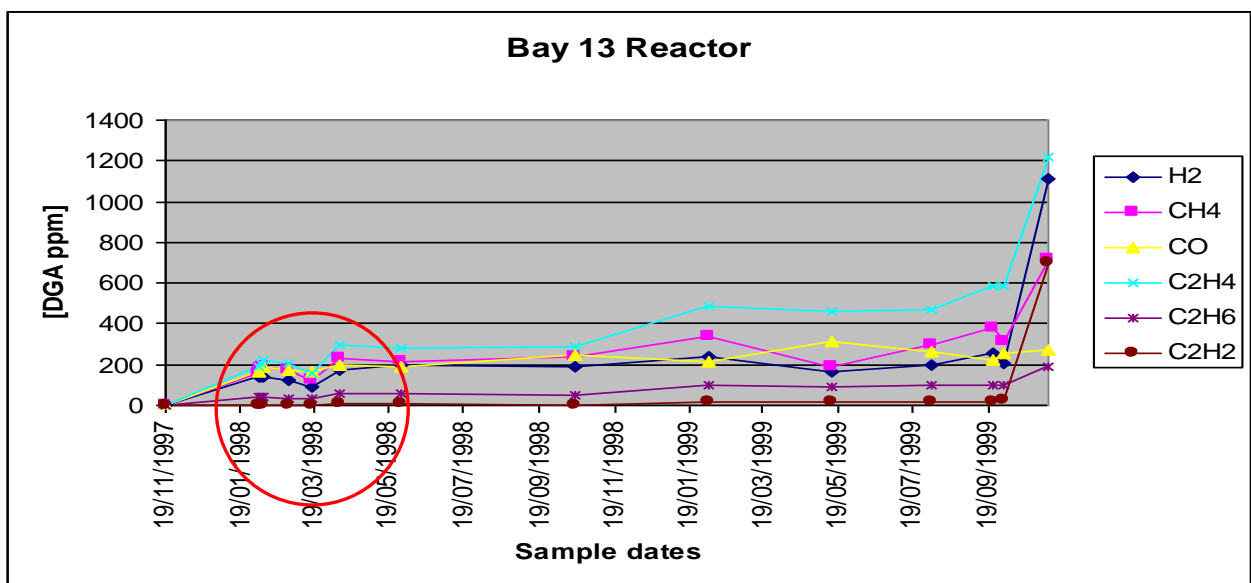
Figure 19: DGA trend

On the 05th November 1999, a gas trip was triggered by the Buchholz relay. The urgent DGA on the oil sample confirmed an arcing condition (IEC 599-Discharge of high energy). This transformer also had a gassing pattern showing a thermal fault with the initial indication in February 1998. See Figure 19 giving the Graph trend.

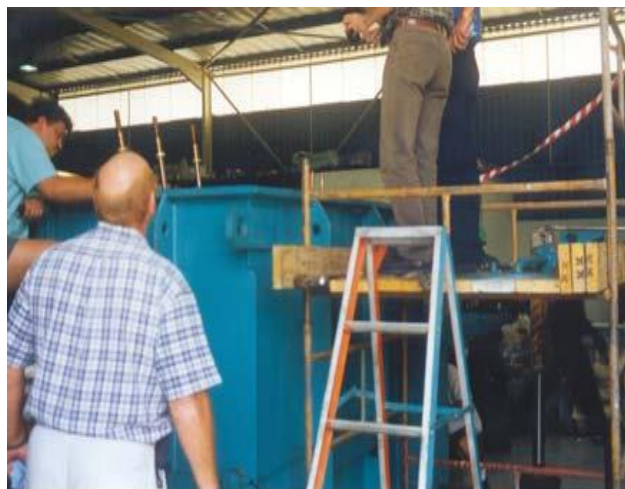
Figure 20: Reactor transformer being De-tanked at the Works facility

The transformer was removed to a Works Facility for Inspection and repairs. See Figure 20

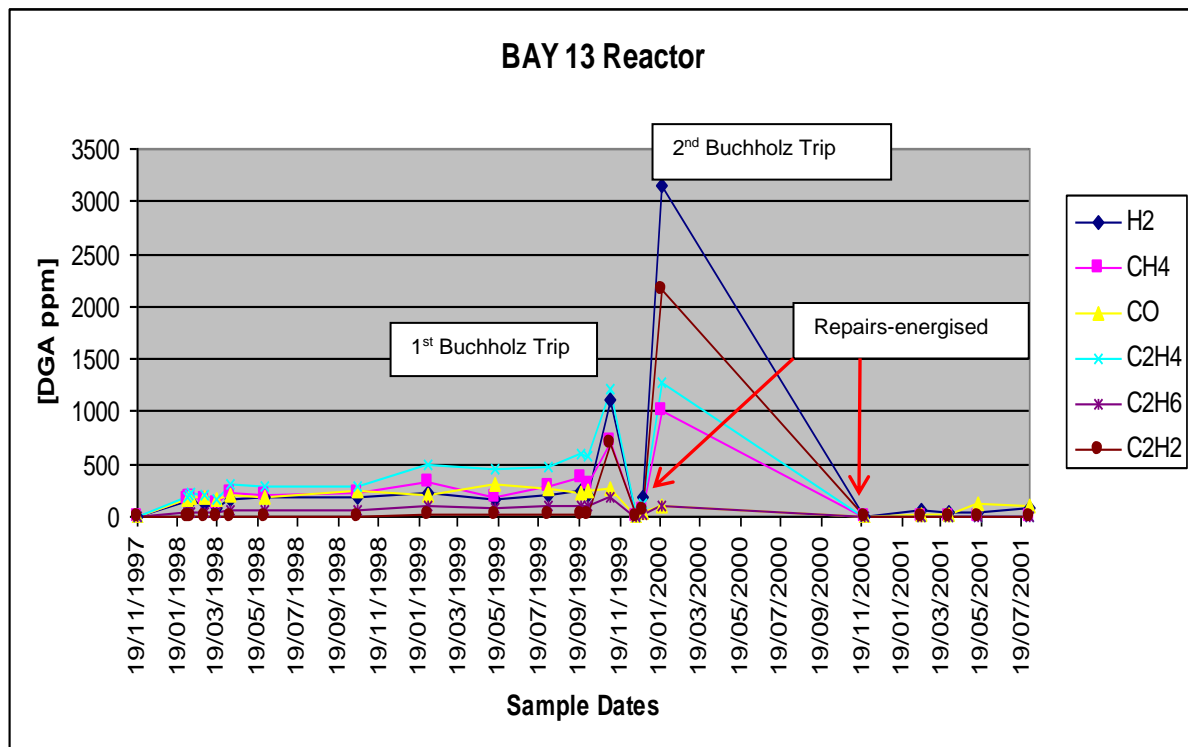
Figure 23
DGA Trend

On the 21/01/2001, another gas trip was triggered by the Buchholz relay. The urgent DGA on the oil sample again confirmed an arcing condition (IEC 60599-Discharge of high energy). It is interesting to note that the sample taken 24/12/1999 was already indicating a discharge of high energy due to the overstressing of the resistor bank. See Figure 23 giving the Graph trend.

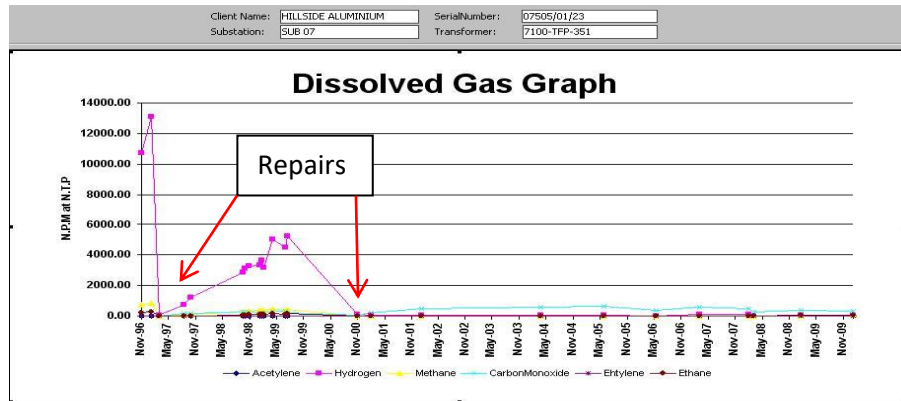
Figure 26
DGA Trend

The transformer was repaired by the manufacturer in February 1997; however DGA samples taken after re-energisation showed that the repairs had not been effective. The unit was returned to the manufacturer in August 1999 for further repairs that were effective. See Figure 26 Showing the DGA trend which also acts as a timeline.

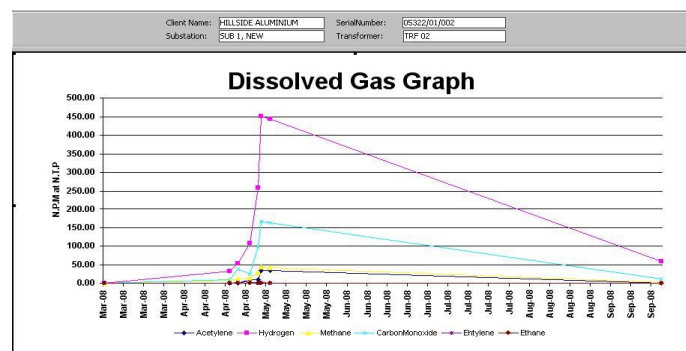
Figure 27
DGA trend

The DGA on this transformer showed abnormal gas production of hydrogen and methane. See Table 22 giving the name plate data and Figure 27-shows the DGA trend. Although the actual levels were only in the elevated range according to the CSUS, the production rates and Ratio methods provided enough evidence of serious Partial Discharge activity. The design review was also considered when taking the decision to remove it from service for an internal inspection. Previously four similar transformers had been returned to the manufacturer. In all of the cases DGA had identified the Partial Discharge.

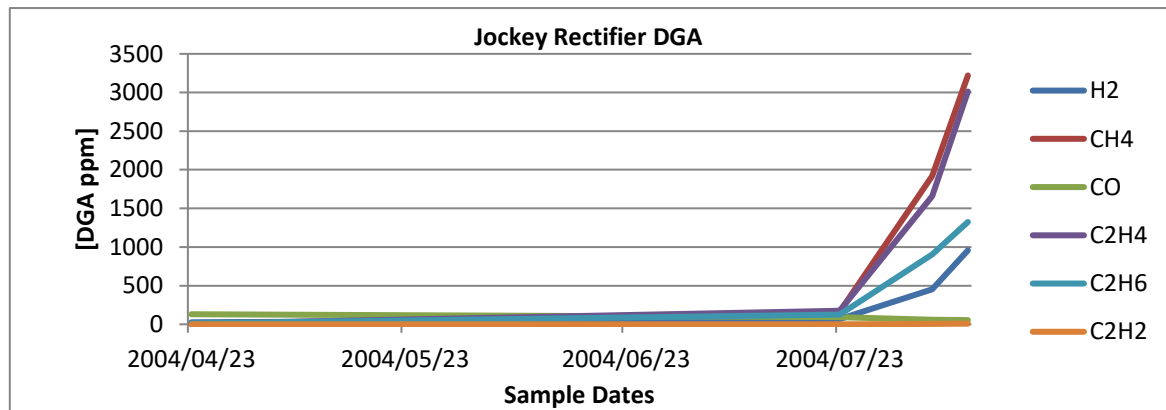
Figure 29: DGA Trend

The DGA on this transformer showed abnormal gas production of hydrogen, methane, ethylene and ethane about 20 months after Energisation. The fault condition was diagnosed as a thermal fault of medium temperature in the range 300°C-700°C. The recommendation was to remove from service for Inspection. See Table 23 giving the name plate data and Figure 29-shows the DGA trend and Figure 30 the DGA signature.

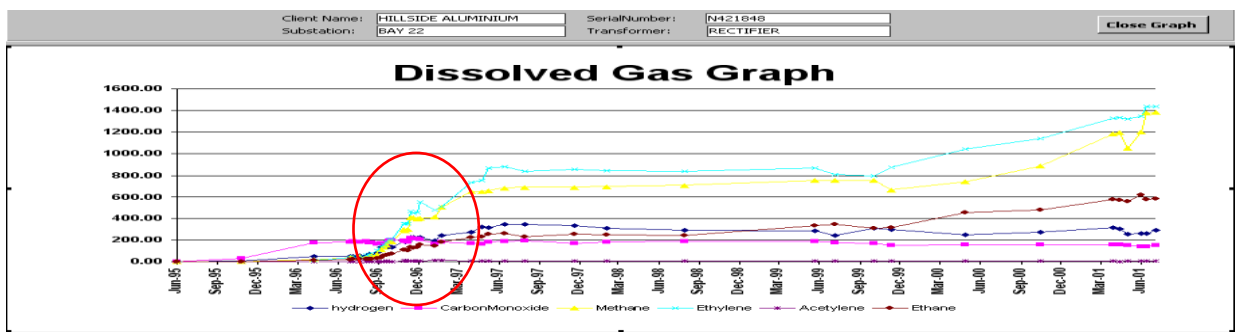
Figure 32
DGA trend up to July 2001

The DGA on this transformer showed abnormal gas production of hydrogen, methane, ethylene and ethane about 20 months after energising. The fault condition was diagnosed as a thermal fault of Medium temperature in the range 300°C-700°C. The recommendation at 30/09/1996 was to remove the unit from service for Inspection. See Table 24 giving the name plate data and Figure 32-shows the DGA trend with Figure 33 showing the DGA signature.

It is interesting to note the gas production after July 1997 showed only a slight rate of rise. See Figure 29. However, after the oil de-gassing in July 2001, the same phenomenon of exponential gas production followed by a levelling off was seen. See Figure 32. This can be explained in part by the IEC 60599 code that reports that there can be gas diffusion losses for in service equipment. However, there is no agreement concerning the magnitude.

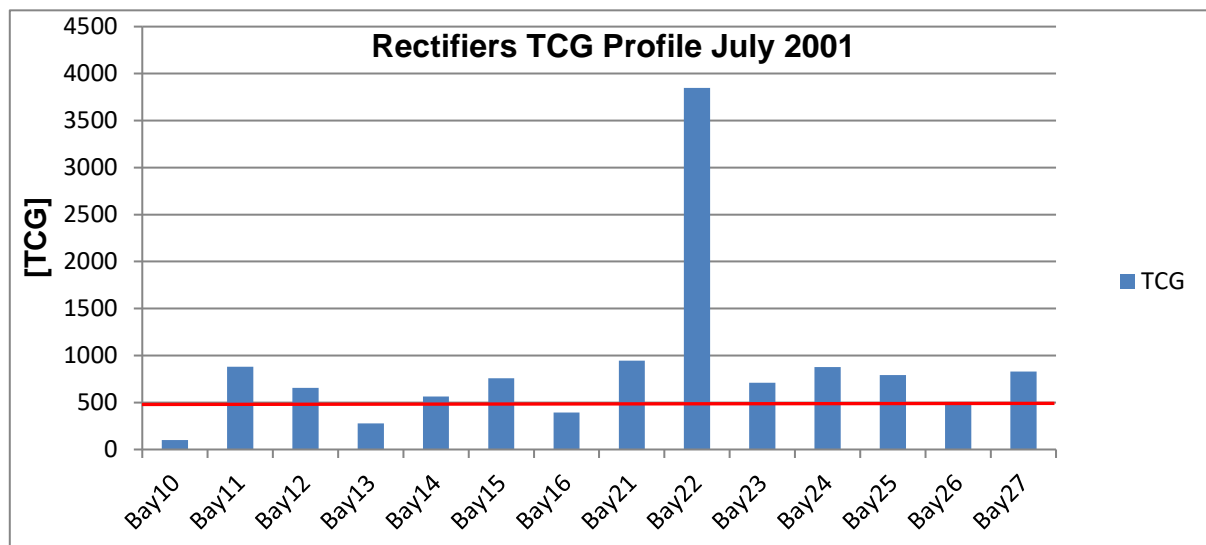
Figure 34
Total Combustible Gas Profile at July2001

The manufacturer's contention was that, although this was not a normal gassing pattern it was not serious enough to warrant removing the unit from service. The manufacturer's in-house expert advice was to monitor the gassing pattern until exponential increase was seen. The exponential rise can be seen from 1996 to 1997. See Figure 34.

This transformer was ranked as having the highest risk of failure, based on the DGA-Total Combustible Gas profile-See Figure 31 showing all Rectifier transformers at July 2001. The condition was monitored by regular oil samples. On-line DGA was considered.

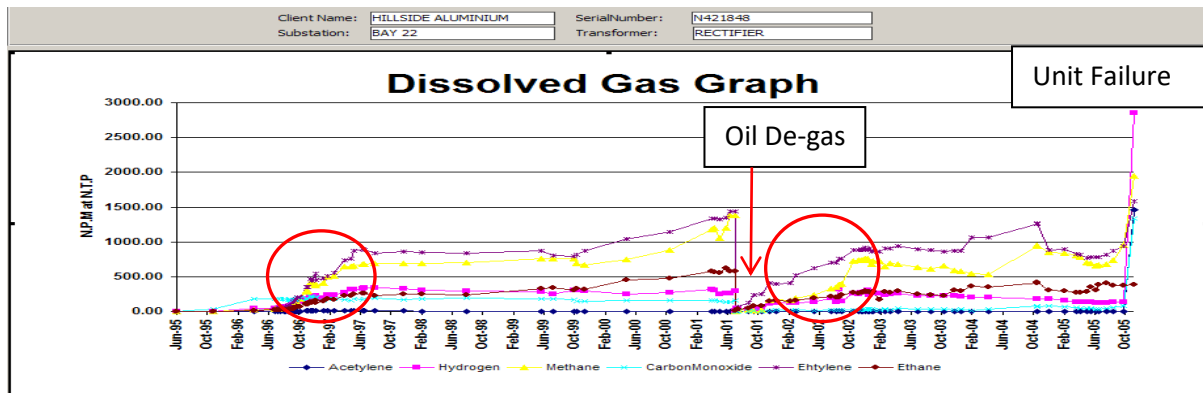
Figure 35: DGA trend

At 16:32, on the 18 November 2005, Transformer T22 failed catastrophically. An urgent DGA sample confirmed that a discharge of high energy (Arcing) had occurred. See Figure 35 showing the DGA trend

When T22 transformer failure developed the entire sequence of events, equipment failures and trips were over in approximately one second.
