Dissolved Gas Analysis (DGA) role in Improving the Reliability of Wind Farm Transformers in Southern Africa.

Ian Gray

Oilwatch Transformers Services

11th
REGIONAL
CONFERENCE
POWER SYSTEM TECHNOLOGIES FOR
SUSTAINABLE GROWTH IN AFRICA

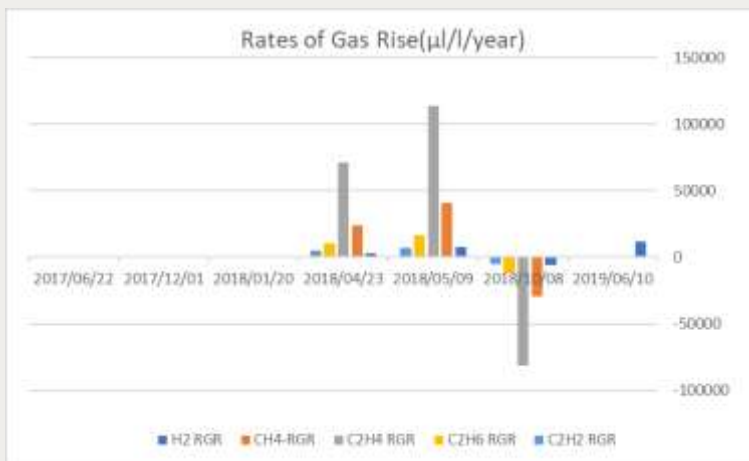
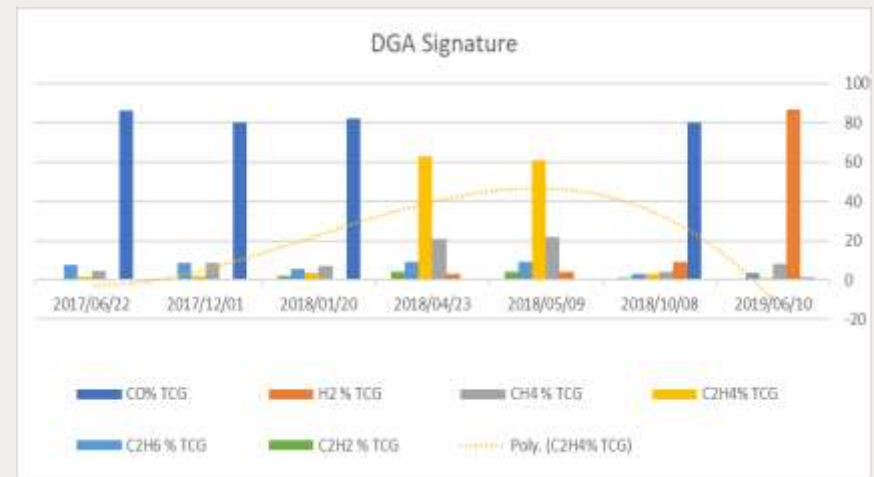
Rates of Gas Rise(RGR)

- between the samples dated 2018/05/10 to 2018/04/23

H ₂	CH ₄	C ₂ H ₂	C ₂ H ₄	C ₂ H ₆	CO	CO ₂	TCG
ppm /year	4109	11472	1083	23544	3422	110	145	43741
Ranges of 90 % typical rates of gas increase (IEC 60599)	35–132	10–120	0–4	32 – 146	5–90	260–1060	1700-10000	
ppm/day	11,26	31,43	2,97	64,51	9,38	0,30	0,40	119,84

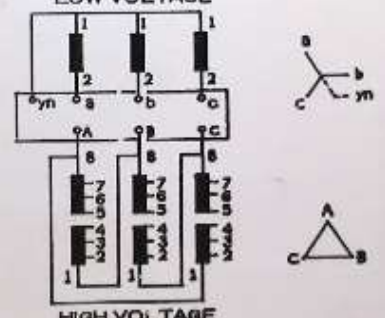
kVA	2700	COOLING	O.N.A.N.
H.V. VOLTS	33000	OIL litres	1680
L.V. VOLTS	690	CORE & WINDINGS	4430 kg
H.V. AMPERES	47.2	TOTAL MASS	7750 kg
L.V. AMPERES	2259.2	SERIAL No.	DS13105N/06
PHASE	3	ORDER NO.	CONCO/5
IMPEDANCE	9.25 %	YEAR OF MANUF.	/2014
FREQUENCY	50 Hz	IMPULSE LEVEL	200 kV
DRAWING No.	L-0001	STOCK No.

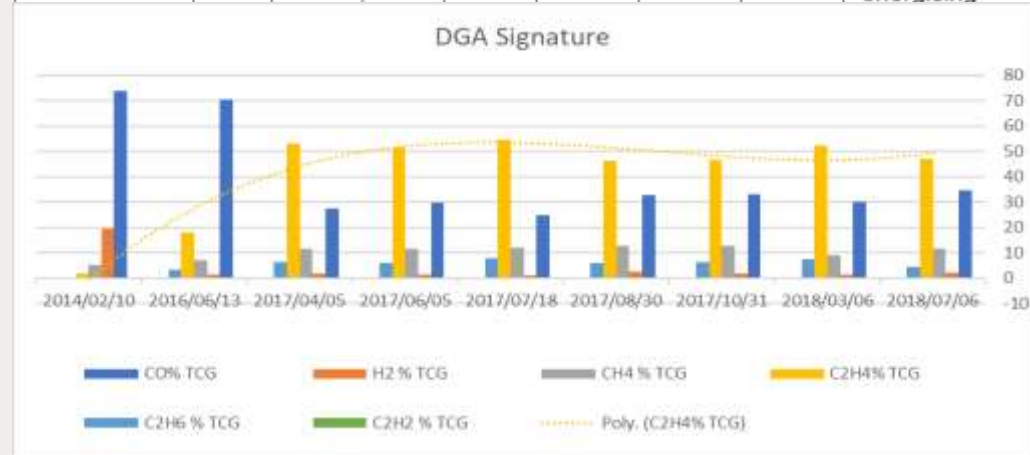
- The abnormal gassing pattern was evident after Energisation on load, (Warranty issue)
- Nameplate information

Sample Date	H ₂	CH ₄	CO	CO ₂	C ₂ H ₄	C ₂ H ₆	C ₂ H ₂	Sample Type
2018/07/06	35	181	539	8148	729	68	0	
2018/03/06	12	91	312	5393	542	76	0	
2017/10/31	21	147	383	5604	543	71	0	
2017/08/30	33	179	461	6553	647	83	0	
2017/07/18	9	111	233	4645	511	74	0	
2017/06/05	19	144	370	5635	647	74	0	
2017/04/05	18	123	293	4740	569	67	0	
2016/06/13	17	91	901	7494	230	39	1	
2014/02/10	11	3	42	221	1	0	0	Prior energising

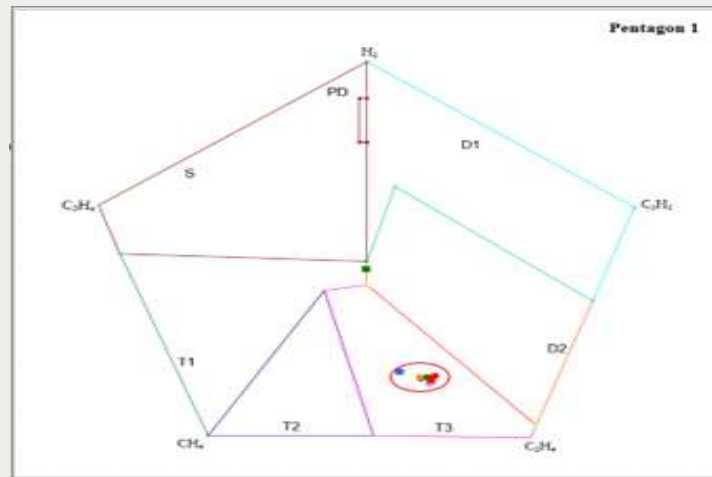
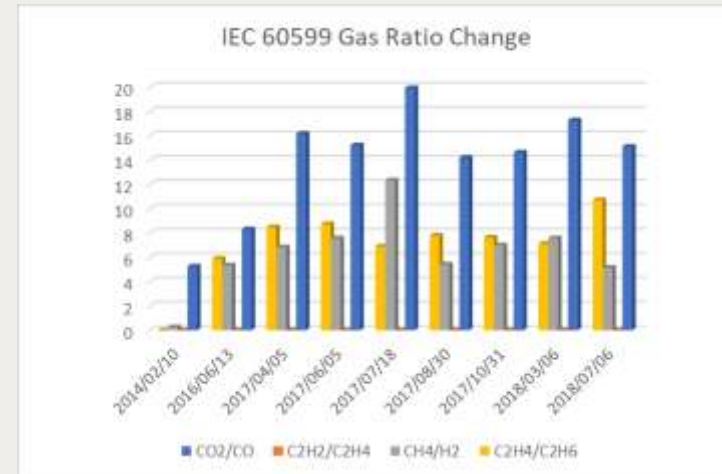
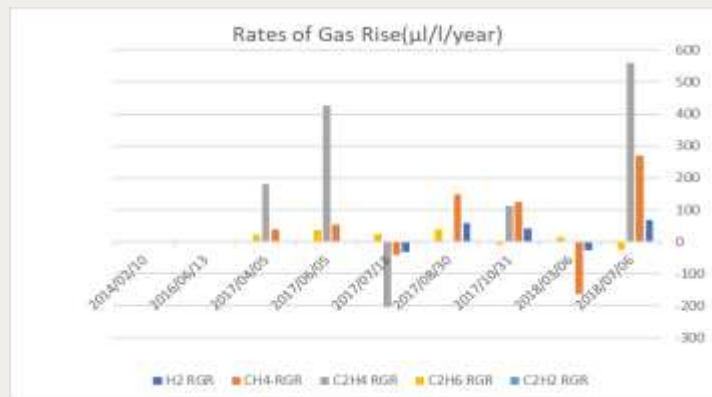
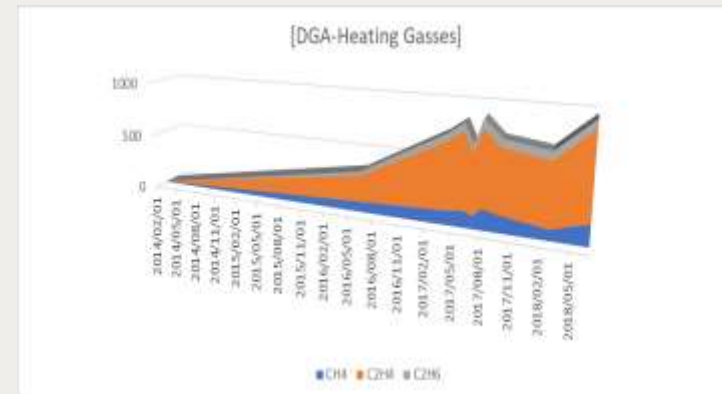
Fault diagnosis

- Duval Pentagon-Thermal Fault(T3) : IEC Ratio's-T3 t > 700 °C

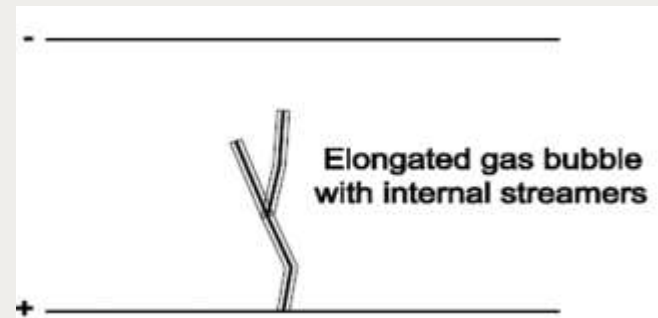
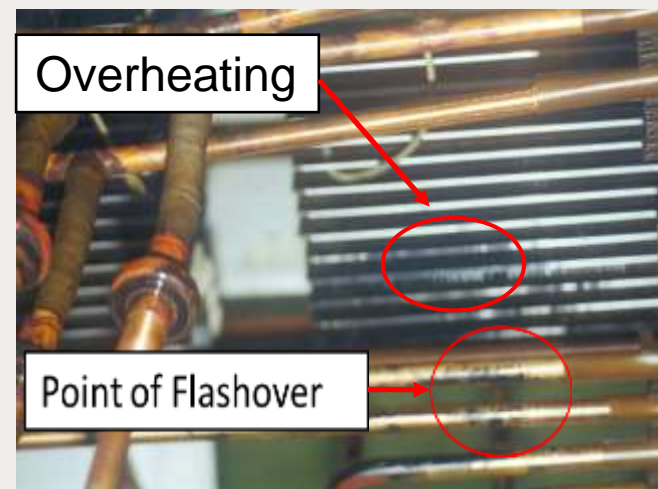
Safety concerns

- High Levels of Hydrogen and Hydrocarbons in Active Transformers
- Gas Bubble formation-elongate in the direction of the electric field
- Mechanism of the flash-over-voltage stress caused by gas bubble formation
- Root cause: 5th Harmonic
